Wildlife Crossing Structures: Planning, Placement, Monitoring

DESIGN, INSTALLATION, AND MONITORING OF SAFE CROSSING POINTS FOR BATS ON A NEW HIGHWAY SCHEME IN WALES

Dr. Stephanie Wray (Phone: 01453 731231, Email: swray@cresswell-associates.com), **Paola Reason, David Wells, Warren Cresswell** and **Hannah Walker**, Cresswell Associates, The Mill, Brimscombe Port, Stroud, Gloucestershire GL5 2QG United Kingdom

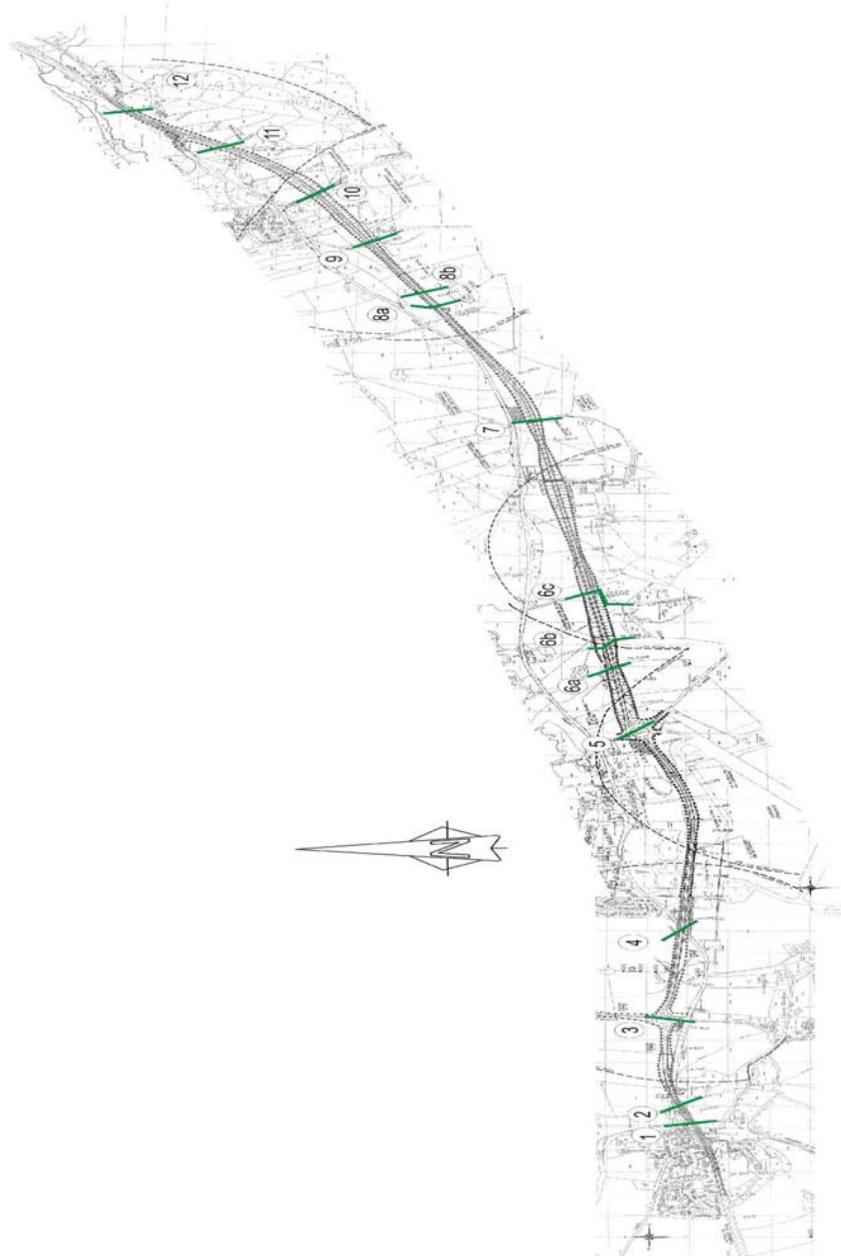
Figure 1. The location of potential bat crossing points.

The points at which bats were most likely to encounter, and cross, the new road were identified, in order to inform mitigation requirements. This was achieved both by assessing the existing bat survey and radio-tracking data, and on the basis of a walk-over survey. The potential significance of the impact of the scheme on greater horseshoe bats was not fully recognized during early scheme development, but during detailed design work by the authors at the start of construction. A total of 12 potential crossing points were identified, as shown in figure 1.

Bats could encounter the route of the new road in a variety of locations, but these points represented the most likely features that horseshoe bats would use. They comprised single discrete features (for example, a lane bounded by hedgerows which was relatively isolated from other potentially valuable features for foraging or commuting bats), or clusters of potential crossing points (for example, a group of hedges intersecting the route). Monitoring these potential crossing points involved pairs of surveyors stationed at appropriate locations. Some remained largely stationary at suitable vantage points; others patrolled short transects in order to "cover" adjacent features. At each location, bats were recorded and identified by using a combination of heterodyne and time-expansion bat detectors. In particular, time-expansion detectors were used to record the sounds of the different species heard, and these recordings were downloaded onto a computer and their sonograms analyzed to confirm field identifications. At all locations, the surveyors focused on detecting horseshoe bats, but as many other bats as possible were recorded incidentally.

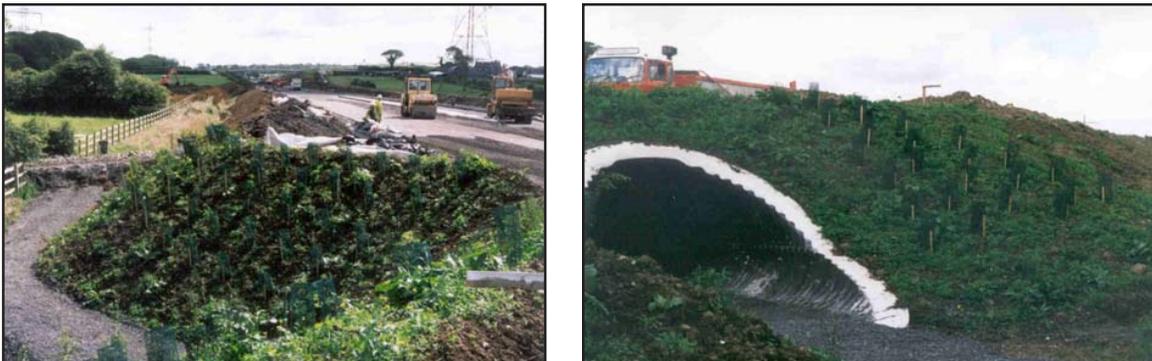
Figure 3. Planting at the bat culvert. These photographs show the planting at an early stage. In the photograph to the left, the culvert is located in the recess.

Container-grown plants were used to replace/restore linear features removed during the works, to guide bats to the culvert mouths.

1. *Crataegus monogyna* (120-150 cm)
2. *Salix caprea* (80-100 cm)
3. *Salix cinerea* (80-100 cm)
4. *Sambucus nigra* (80 cm)
5. *Ilex aquifolium* (40-60 cm)
6. *Rosa canina* (60-80 cm)
7. *Prunus spinosa* (60 cm)

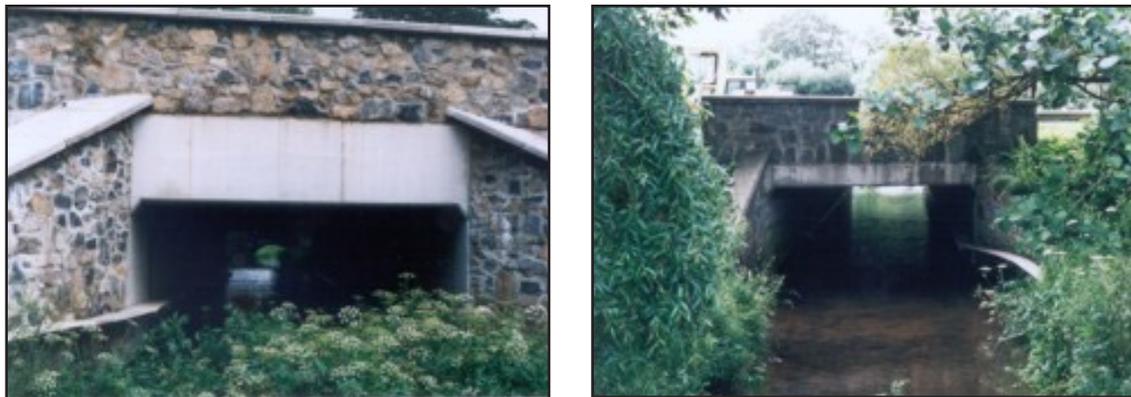
Figure 4. The Milton culvert

Following installation of lighting at the Milton road junction, close to the culvert used by greater horseshoe bats (shown in figure 4), it was noted during surveys in 2003 that light levels at the mouth of the southern end of the culvert were increased, compared to 2001 and 2002, but not at a regular level across the entrance – one area slightly darker than another. A lighting column on the south side of the A477, located above and to the west of the culvert, spills light behind the lighting column and away from the road. A lighting column to the north of the A477 (east of the culvert) also sheds lights across the road and across the culvert mouth.

Levels of greater horseshoe bat activity at the Milton culvert remained high throughout the 2002 survey season. In 2003, however, and subsequent to the road opening in late 2002, the levels of greater horseshoe bat activity at Milton culvert were significantly reduced. The reduced levels of activity were particularly apparent in summer 2003, as no greater horseshoe bats were recorded on three survey visits in June and July. The culvert is most in use during spring, and, therefore, the patterns of use are seasonal as well as related just to light levels. It is considered highly likely that this reduction in activity is a result of the increased light levels at the culvert mouth on the southern side of the scheme (primarily due to the lighting column on the west side of the culvert south of the road), as horseshoe bats are known to avoid well-lit areas. The bats that were observed using the culvert in 2003 appeared to modify their behavior in response to the lighting by hesitating before flying faster and lower between unlit area.

The area between the headwall of the culvert and the ends of the wingwalls be screened more effectively.

The latter could be achieved by the planting of, for example, willows on each side of the watercourse tied together at the tips to create a "natural" arch extending out from the culvert mouth, or by provision of a screen. Potential screening methods include using standard "garden" type fencing panels or using standard street furniture materials, such as a blank road-sign panel fixed on posts and aligned parallel to the existing fencing running down the wingwall.

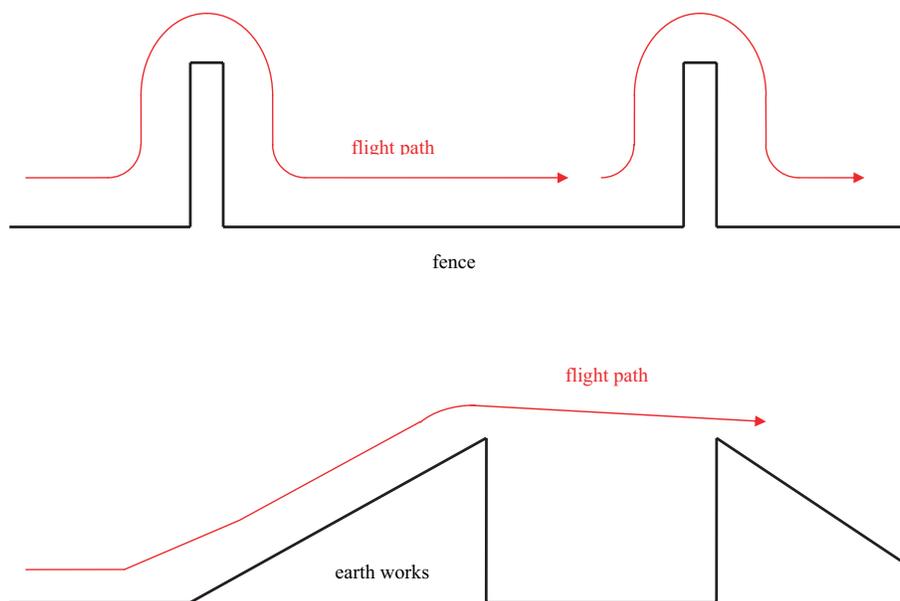
Figure 5. Flight paths of lesser horseshoe bats over obstructions.

The A487 from Llanwnda to south of Llanllyfni Improvement in North Wales is close to a site of European value for lesser horseshoe bats and severs a number of regularly-used commuting routes. Like the A477, it is a single carriageway scheme. There have been records of bat casualties of the common pipistrelle, soprano pipistrelle, brown long-eared (*Plecotus austriacus*), and lesser horseshoe bat (Billington 2001, 2002, 2003). A number of innovative mitigation techniques are being used for Lesser Horseshoe Bats on this scheme with mixed success. Some have proved to be more successful than others, including semi-permanent bollard based lighting to deter bats from crossing the road and divert them to an underbridge; and fencing to guide bats to that location. However, much of the fencing that had been installed to prevent bats from crossing the road, 2 m and 4 m high, with single and double cranks at the top of the fence, has not worked as well as expected. This may relate to the manoeuvrability of lesser horseshoe bats. When they encounter a fence, they fly up over it and immediately twist to return to their original flight path height.

In contrast, gently-sloping earthworks (false cuttings) seem to have greater success in extending the bats' higher flight path. If the potential impact on bats had been better recognized at an earlier stage, more effective means of "lifting" bats up and over the road might have been possible.

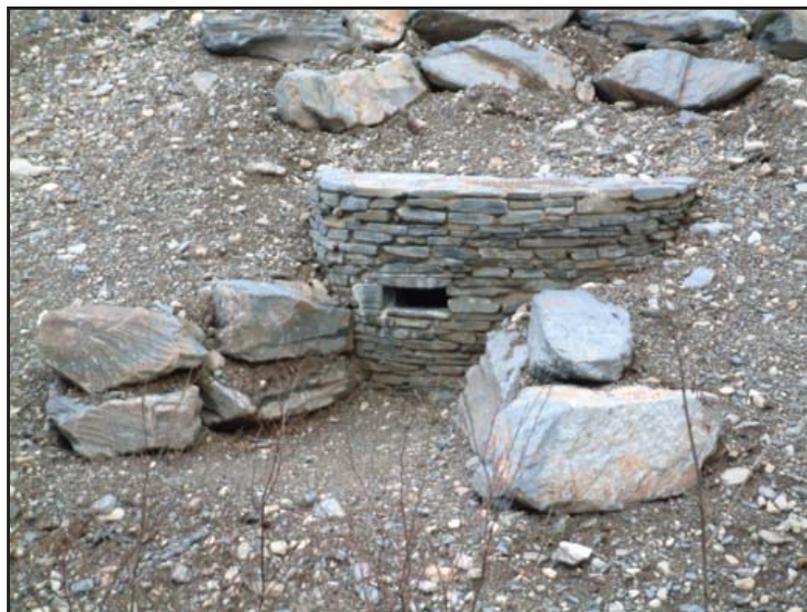
Figure 8. External view of the bat hibernation chamber at Lledr, showing the letter-box-sized entrance to the underground chambers.

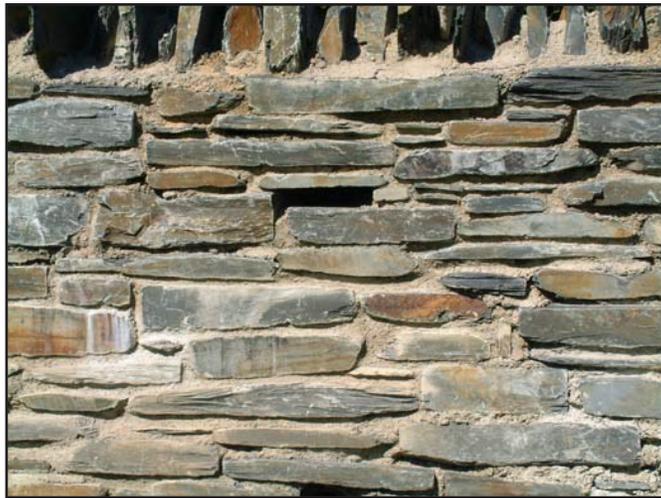
Figure 9. Entrance to the bat chamber within the retaining walls at Lledr.

A second mitigation measure involved providing bat roosting sites within the dry stone retaining walls for the road. This comprised letter-box-sized entrances (shown in figure 8) leading to small chambers within the road embankment. This not only provided suitable roosting sites for bats, but also provided a refuge for other species, including reptiles.
