**CREATING RESILIENT WILDLIFE UNDERCROSSINGS WITH  
INTERLOCKING PAVEMENT BLOCKS**

## **ABSTRACT**

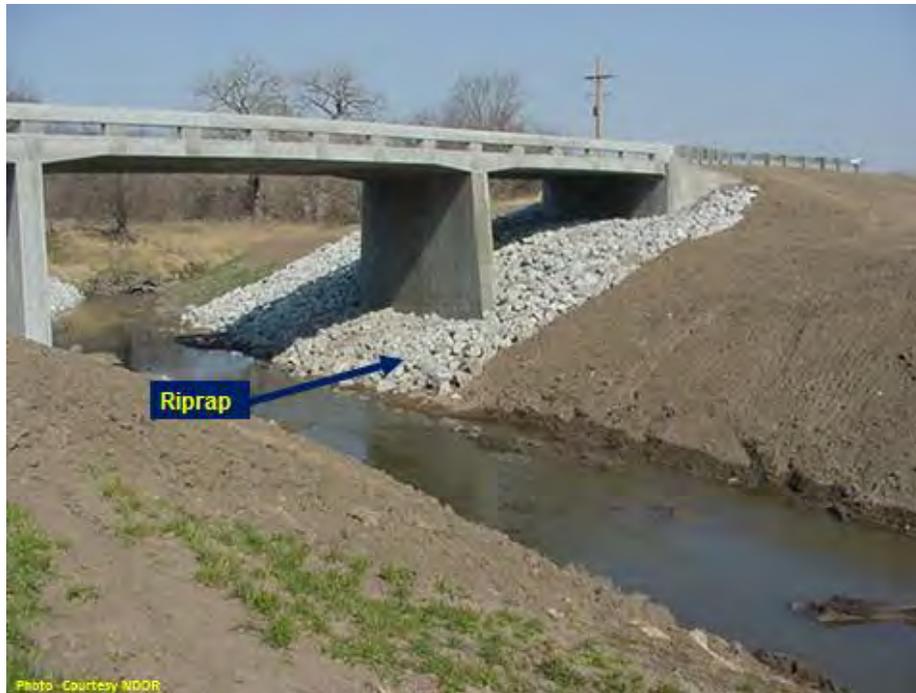
The current design standard for armoring bridge piers and abutments in channels includes rock riprap, which is the placement of several tons of 2-ft (0.6 m) diameter solid rock. The riprap typically surrounds the abutment and piers to prevent scouring of the channel bank (Figure 1) from high water and to catch storm water falling off the bridge deck. Although a minor cost in comparison with the multi-million dollar structure that is being protected, riprap does not allow vegetative growth to occur for several years, if at all. In addition, as the riprap is placed on top of the soil and does not become a cohesive part of the slope, maintenance personnel check the riprap locations every few years for movement from the concerned areas to determine if reapplication is needed. Wildlife biologists believe the large diameter riprap prevents deer and other wildlife from using the undercrossings and instead forces movement across roadways (Austin and Garland 2001, Cramer and Bissonette 2005).

**FIGURE 1. Typical scour protection on Nebraska bridges.**

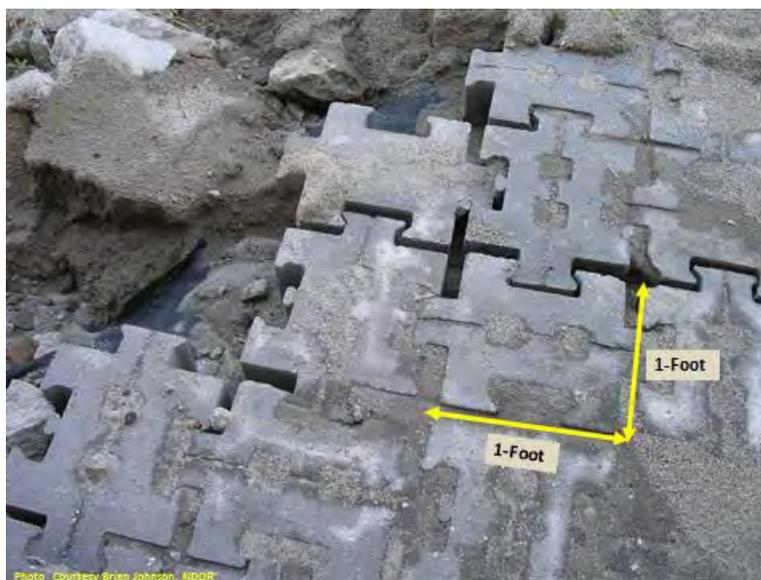
Roadway culverts and earth ditches often use “interlocking pavement blocks” (IPB, Figure 2). These IPBs are available throughout the world as an erosion control block with applications for retention basins, shoreline protection, and drainage ditch lining. Interlocking pavement blocks can be substituted in place of riprap in some instances and may provide additional ecological benefits. IPBs allow growth of local vegetation between voids eventually creating an unnoticeable erosion grid that is accessible to wildlife and will continue to provide long-term scour protection.

**FIGURE 2. Interlocking pavement blocks.**

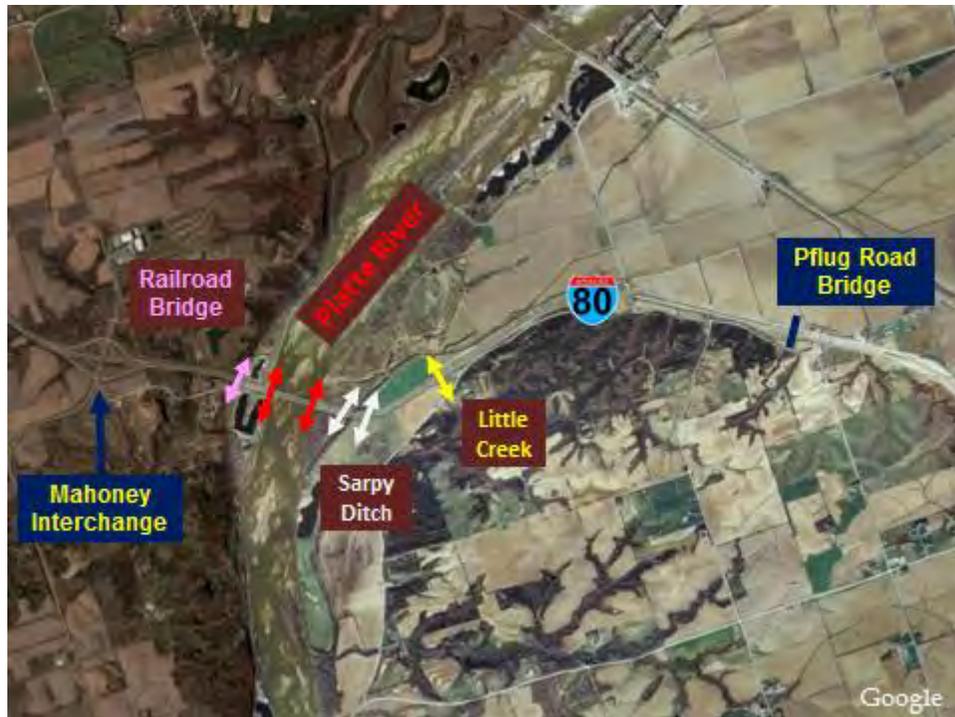
**FIGURE 4. Locations of modified undercrossings. Colored arrows indicate the locations of the 6 undercrossings.**

Overhead structures were reconstructed to span the new interstate and the 35-foot (10.7 m) lateral obstacle clearance. Some were realigned in new locations to eliminate geometric deficiencies. The Pflug Road Bridge (Figure 4) was relocated west of the existing structure as the county officials agreed to remove the old Pflug Road Bridge and Ruff Road Bridge and combine funds for a larger structure.

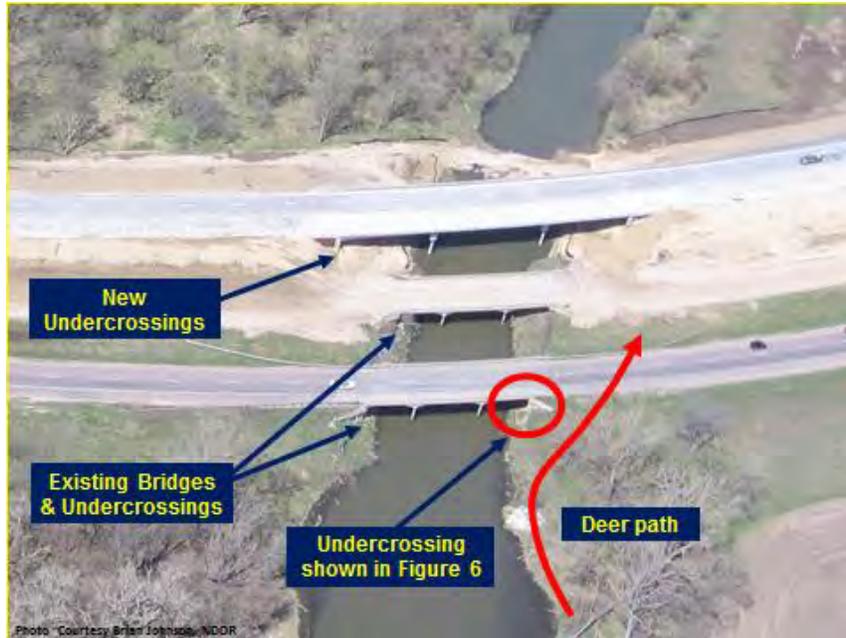
Prior to the project, a field check of the existing bridges was made to determine the functionality of the undercrossings. At the Sarpy Ditch Bridge (Figure 5), a deer path was clearly visible which skirted past the bridge and headed directly toward interstate traffic.

**FIGURE 5. Sarpy Ditch Bridge, April 2007**

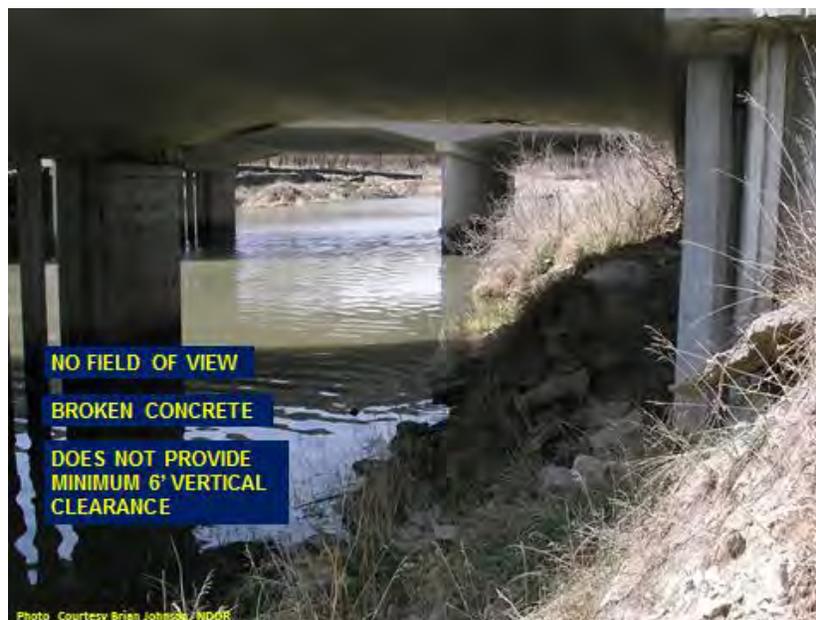
As these bridges were constructed in the 1960's, the only engineering standard considered as part of the design was to provide an opening which met the hydraulic needs of the channel. No design standards for animal crossings were available or even considered at that time. Each bridge could be classified as an inoperable deer undercrossing as these did not provide a good field of view, had broken concrete strewn about the potential pathway, and did not meet the minimum 6-ft (1.8 m) vertical clearance necessary for antlered deer (Figure 6).

**FIGURE 6. Existing Sarpy Ditch Bridge undercrossing.**

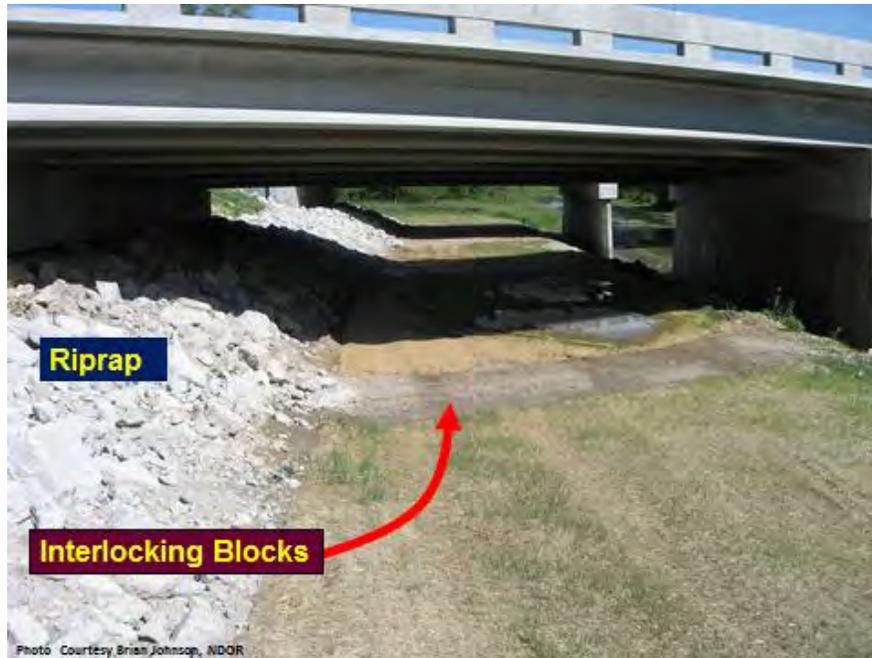
We limited riprap placement to protect the abutment bank and allow the flat berm to be free of obstacles (Figure 7). Redesigned underpasses ranged in width from 36 feet (11 m) at the Sarpy Ditch Bridge to 104 feet (31.7 m) at the east shore of the Platte River. The bridge spans at the Sarpy Ditch and Platte River bridges were extended due to the hydraulic needs for conveying water during ice jams and facilitation of wildlife use. As part of the 6-lane expansion project, we constructed 6-ft (1.8-m) wide grids with IPBs centered under the drip line of each side of the bridge decks to eliminate scouring and reduce the velocity as the water spreads onto the adjacent soil berm.

**FIGURE 7. New wildlife undercrossing at Sarpy Ditch Bridge, May 2009.**

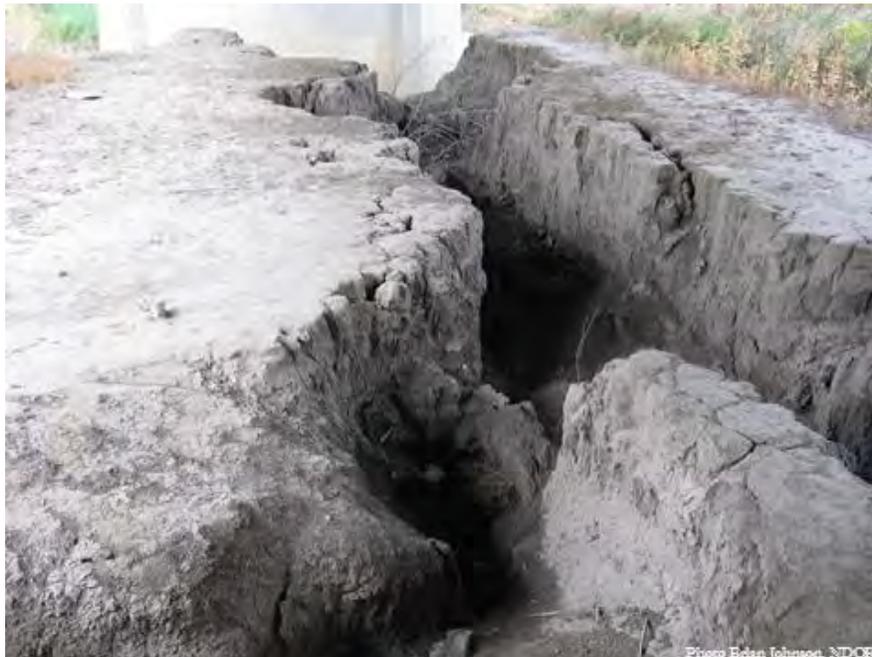
Unprotected soil under bridges can be scoured easily (Figure 8), requiring significant maintenance work on a frequent basis as well as making the undercrossing impassable for wildlife. We specified that the blocks toe into the riprap to collect any water flowing off the abutment bank.

**FIGURE 8. Example of the erosion that can occur along the drip line of an unprotected undercrossing. Salt Creek Bridge, Mile Marker 407.97, October 2010.**

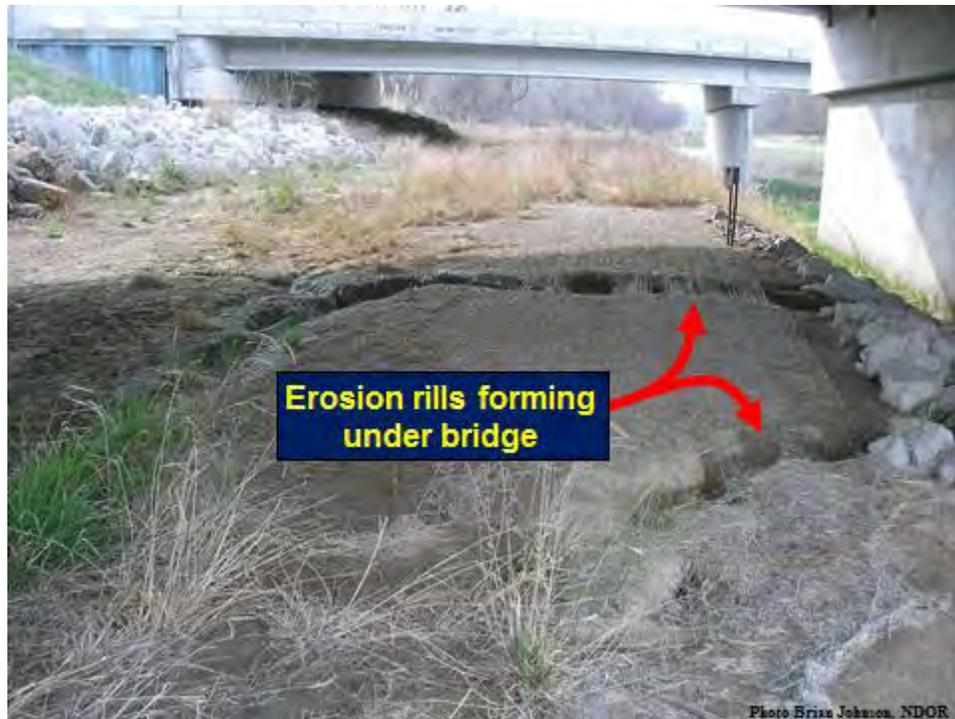
We did note that the IBP plans should provide more detailed construction information to provide a high point in the undercrossing constructed directly under the bridge. This will prevent storm water from accessing the middle of the bridge and eroding soil which typically does not have vegetation, as is evidenced at the east shore of the Sarpy Ditch Bridge (Figure 12).

**FIGURE 12. East shore of Sarpy Ditch Bridge, April 2013**
