**SAVING LIVES AND TRAINING THE NEXT GENERATION:
STATE ROUTE 101 WILDLIFE CORRIDOR SAFETY PROJECT**

June 17, 2013

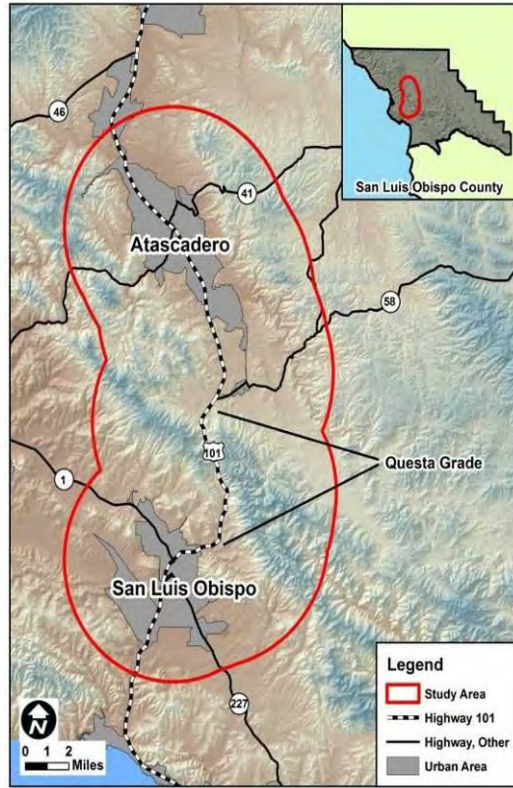
FIGURE 2 Wildlife connectivity study area.

Independent of the fencing project, Caltrans also initiated a two-pronged wildlife connectivity study associated with a median barrier project proposed for the same stretch of highway. In 2009, Caltrans began an ongoing collaboration with California Polytechnic State University (Calpoly) in San Luis Obispo to conduct field studies to document roadkills, roadside activity and use of existing underpasses by wildlife (Perrine et al. 2011). In addition to the field studies, Caltrans also contracted with the Information Center for the Environment at U.C. Davis to model the suitability of the wildlife connections across SR 101 for habitats in the vicinity of the project (Thorne et al. 2011). Results from these studies helped guide design decisions for the installation of the wildlife exclusion fence. The fence was installed in a roadkill hotspot for black bear identified by the Calpoly study, and in an area identified by the UC Davis model as having high potential for connectivity for both black bear and mule deer (Figure 2 and 3).

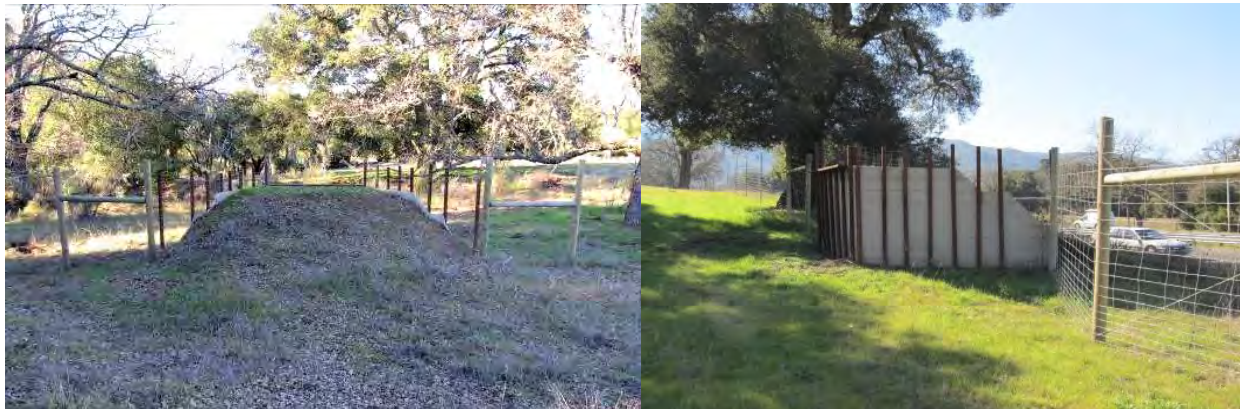
FIGURE 4 Fencing and jump-out.

Fencing materials included 8-foot high graduated wire mesh fencing, 10-foot high steel T-post and 10-foot high wooden treated post set in concrete. The jump-outs were constructed using recycled tongue and groove plastic boards, used 3 inch steel pipe, the 8-foot high wire mesh fencing material and local dirt to form the earthen ramps on the jump-outs (Figure 4). The vertical height of the jump-outs on the drop off is about 6.5 feet to accommodate coastal mule deer. The fence is being maintained by the California Conservation Corps and Caltrans maintenance; the jump-outs and electric mats are being maintained by Caltrans maintenance.

The camera stations have document mule deer are using the jump-outs, but most observations document the deer approaching the edge and turning around. The first step that's been taken by Caltrans biologist to improve the use of the jump-outs, is the removal of a board that was placed on the edge of each jump-out (See Figure 9) as an experiment to deter wildlife from climbing or jumping into the highway corridor. If the removal of the boards does not resolve the issue, the next recommendation by the author's is to lower the height of the jump-out.

In addition, annual weed removal could help make the jump-outs more visible and less attractive for browsing by mule deer. As a side note, the steel posts used to construct the jump-outs should be capped to prevent attracting birds and small rodents from building nests inside the pipes.

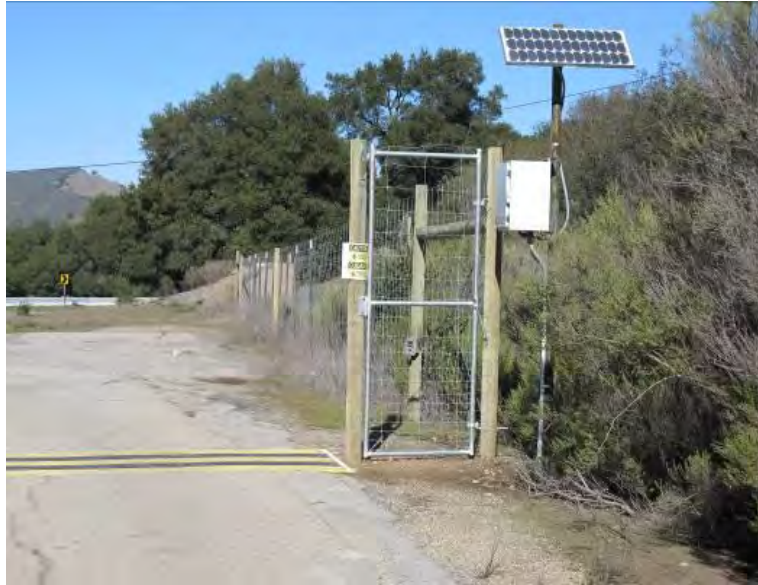
FIGURE 5 Electric mat and solar panel.

The electric mats (Figure 5) are constructed with recycled plastic and contain electrodes that run perpendicular to the road. The mats deliver a 7,000- 9,000 volt shock to animals attempting to cross it and they are powered by a solar panel that charges a 12 volt battery. The mats are posted with warning signs in English and Spanish. The width of each mat is 48 inches and the length ranges from 24 feet to 32 feet.

Based on camera station documentation, there is evidence that the electric mats are more effective at repelling black bear than mule deer. The majority of the observations for mule deer documented crossing events where deer crossed the mats to either enter the highway corridor or exit it. The first recommendation for improving the effectiveness of the mats at deterring deer is to set the energizer for the mat at the appropriate speed (pulse rate per second) for the target species.

The energizer for the electric mats can be set at slow-day speed (2.5 pulses per second) and fast-night speed (1.5 pulses per second) for wildlife active during the night. For wildlife active during the day the speed can be set at fast-day speed (1.5 pulses per second) and slow-night speed (2.5 pulses per second) speed to conserve the battery (User Manual). Caltrans maintenance electricians currently have the speed set for diurnal species because the batteries were draining overnight when set to the speed used for nocturnal species. To improve the operation of the mats, Caltrans biologists are currently working with maintenance staff to trim the vegetation that shades the solar panels at three of the four locations. This may improve the ability of the solar panel to keep the batteries charged and allow the energizer to be reset to slow-day/fast-night speed for wildlife more active at night.

Additional recommendations include eliminating the gap between the post and the electric mat that currently allow some wildlife to skirt the mat. Also the effectiveness of the electric mats could be improved by making them wider and reducing the width of the spaces between the electrodes.

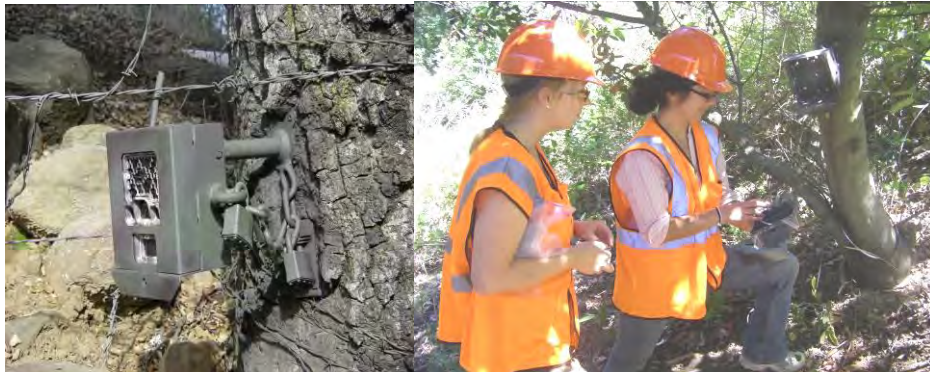
FIGURE 6 Calpoly students checking cameras mounted on trees at undercrossings

All the cameras are mounted to structures, such as metal or wood support posts or trees (Figure 6 and 7). In culverts, the cameras are mounted with epoxy to prevent having screws penetrate the culvert wall. All cameras are mounted using ball joints intended for home stereo speakers; the ball joint allows the camera to be aimed very precisely. The cameras are protected in metal

security boxes and secured with various combinations of padlocks, chain and cable locks (Master Python lock).

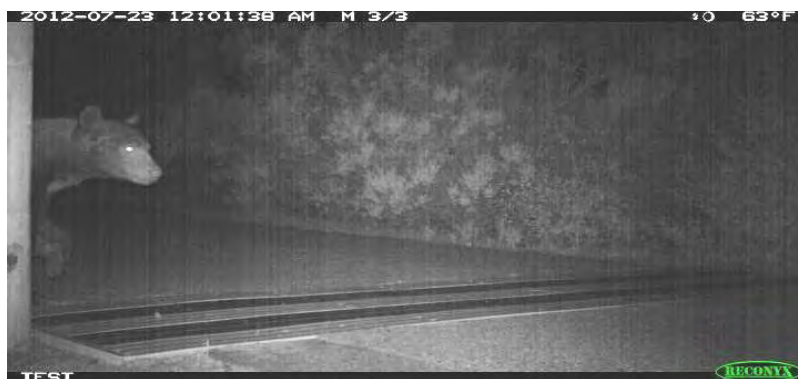
FIGURE 8 Black bear approaches electric mat to enter highway corridor, later retreats.

Black bear (Figure 8) detections at the electric mats and jump-outs have been sparse. Preliminary data documented that a bear was repelled by the electric mat on the east side of the highway at the southern end of the project. In a single incident, a black bear gained access to the highway corridor (from where is unknown) and walked across the southern electric mat on the west side of SR 101. The photo clearly shows that the bear got shocked and leaped off the mat and out of the road corridor. Within the same time frame a bear approached the top of the jump-out just to the north of the electric mat then turned back into the highway corridor rather than jumping off. It is possible this was the same bear that later crossed the mat to exit the highway corridor. This is the only incident where a bear was observed on a jump-out. There were two events that documented a bear crossing the electric mat located on the west side of the highway at the northern end of the project, however, it was later determined that the mat was not turned on at the time. Once the mat was turned on, bear were not observed crossing the mat.

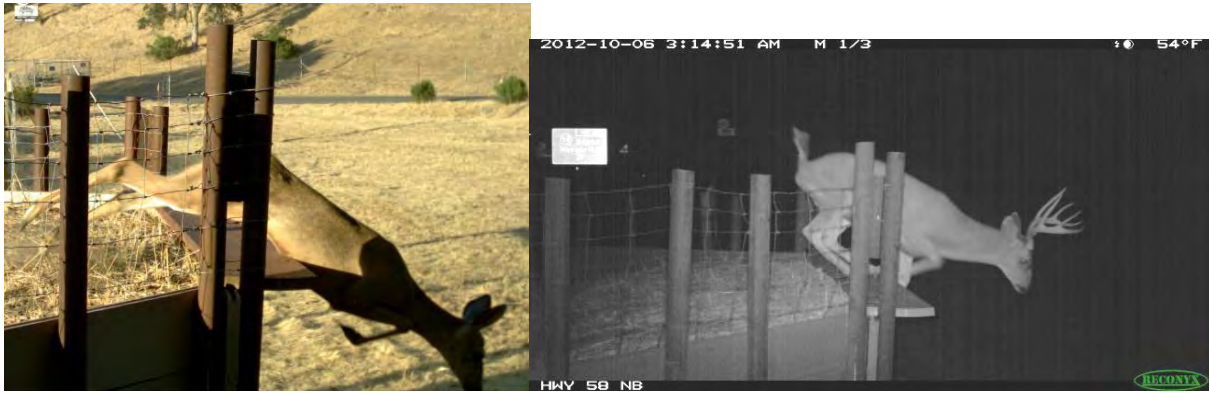
FIGURE 9 Doe and Buck using jump-out to escape the highway corridor.

Mule deer (both does and bucks) have been documented using the jump-outs (Figure 9). In five out of 36 events, deer were observed using the jump-out to escape the highway corridor. For the remaining 31 events, the deer chose not to use the jump-out to leave the highway corridor. Many times the deer walked up the ramp, looked around and browsed a bit, then walked back down the jump-out. Since the deer are not tagged, it is unclear how many individuals are actually involved in the events. It is possible the cameras are detecting just a few animals and individual behavior is playing a role in whether an individual uses the jump-out. In 39 events where deer were detected at or near the base of the jump-out, they never jumped into the highway corridor.

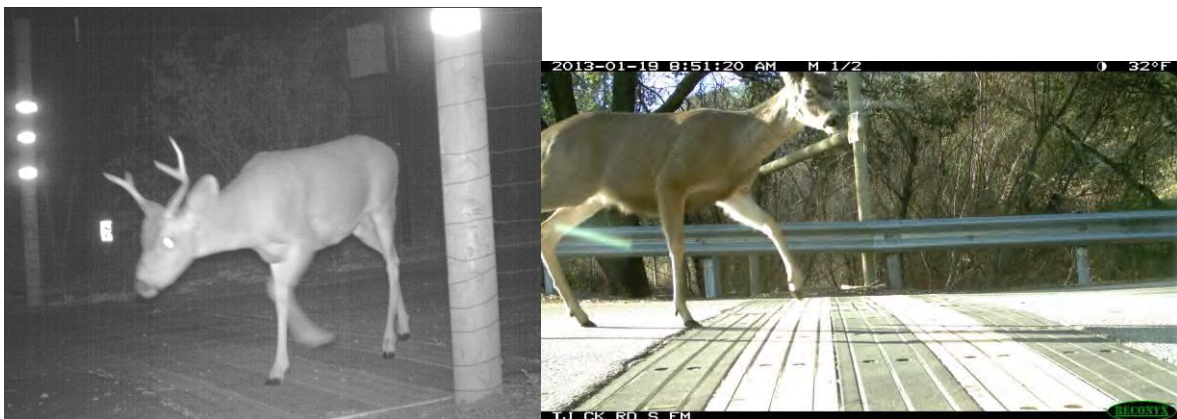
FIGURE 10 Buck crossing mat to enter highway corridor and doe crossing mat to exit.

Preliminary data have documented the electric mats successfully repelling mule deer in 9 out of 63 events. For the remaining 54 events, deer were documented crossing the mats (Figure 10). This includes deer passing in both directions, whether in the highway corridor coming out or outside of the highway corridor going into the roadway. A doe with a fawn or a doe with a trailing buck were counted as 1 event. Again, the deer are not tagged so individuals cannot be identified and it is possible that the same individual may visit on multiple occasions. For example out of the remaining 54 events, it is likely that 44 events involved a single doe with two fawns that repeatedly crossed the electric mat on the east side of the highway at the southern end of the project. This is the same electric mat that successfully prevented a black bear from entering the highway corridor.

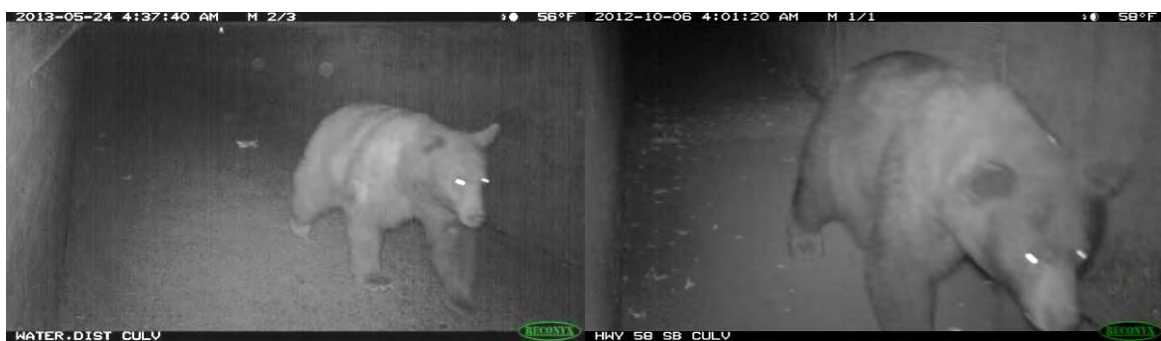
FIGURE 11 Black bear using 4x8 ft. (left) and 4x4 ft. (right) box culvert.

One culvert located about 1 mile north of the railroad overhead crossing is a 4-foot by 8-foot (4x8) reinforced concrete box culvert that is 170 feet in length. The largest culvert located about 0.5 miles further north is a 10-foot by 11-foot (10x11ft.) reinforced box culvert with a 10-foot corrugated metal arch at the inlet. Both of these culverts have the potential to pass wildlife from one side of the highway to the other since each is a single culvert. A third drainage culvert is a segmented 4-foot by 4-foot (4x4 ft.) reinforced concrete box culvert and a portion of it daylights in the median at the SR 101/SR 58 Interchange. This culvert is not connected to the wildlife fence, however, it is being monitored for wildlife that may enter the highway corridor and use it to pass through the interchange area.

Black bear (Figure 11) have been documented using both of the large underpasses and all three culverts within the limits of the fencing project. It is likely that the bear documented using the 4x4 foot culvert at the interchange is breaching the fence near the outlet to the culvert and then moving through at least the first segment of the culvert where it daylights in the median.

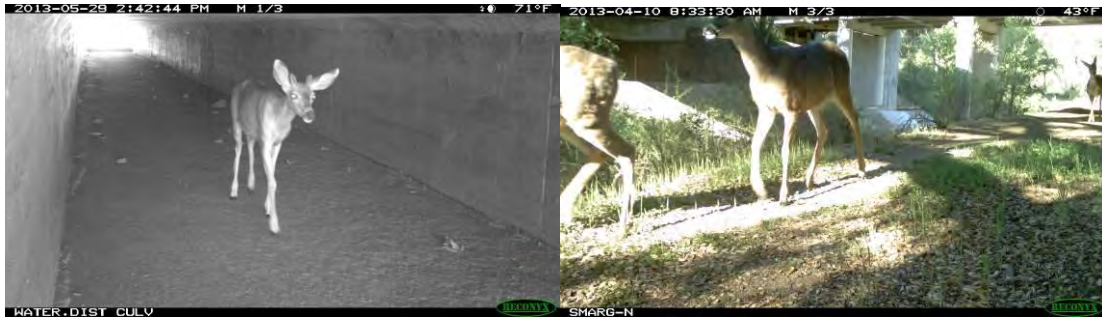
FIGURE 12 Mule deer using 4x8 ft. box culvert and Santa Margarita Creek undercrossing.

Mule deer (Figure 12) have been documented using both of the large underpasses and the 4x8 foot culvert located near the southern end of the project. Although passable by deer, they have not been documented using the 10x11 foot culvert. This culvert is dark and located in a perennial stream channel. As the culvert daylights at the outlet it narrows into a vertical concrete walled open culvert that makes a 90 degree angle turn.

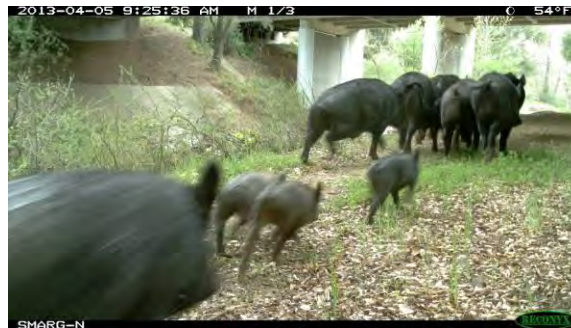
FIGURE 13 Feral pig using the undercrossing at Santa Margarita Creek undercrossing.

Feral pigs (Figure 13) are only using the Santa Margarita Creek undercrossing at the northern end of the project. They have not been documented using any of the other undercrossings.

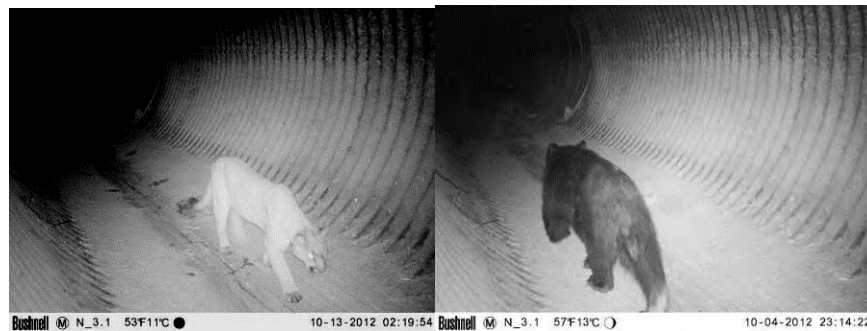
FIGURE 14 Mountain lion and black bear 10x10 ft. corrugated metal culvert.

Within the larger study area, the cameras deployed in the two large culverts south of the limits of the fencing project have documented black bear, mountain lion and mule deer (Figure 14). The cameras deployed in the three large drive-through culverts in the larger study area north of the limits of the fencing project have not detected any of the four target species. These cameras have only recorded smaller mammals such as striped skunk, American badger, and ground squirrels.
