WILDLIFE PASSAGES AND LAND USE: COORDINATION REQUIRED

Tamar Achiron-Frumkin (972-2-5332028 tamar.achiron@gmail.com), Ecological and environmental advisor, PO Box 2444, Mevasseret-Zion 9072747, Israel

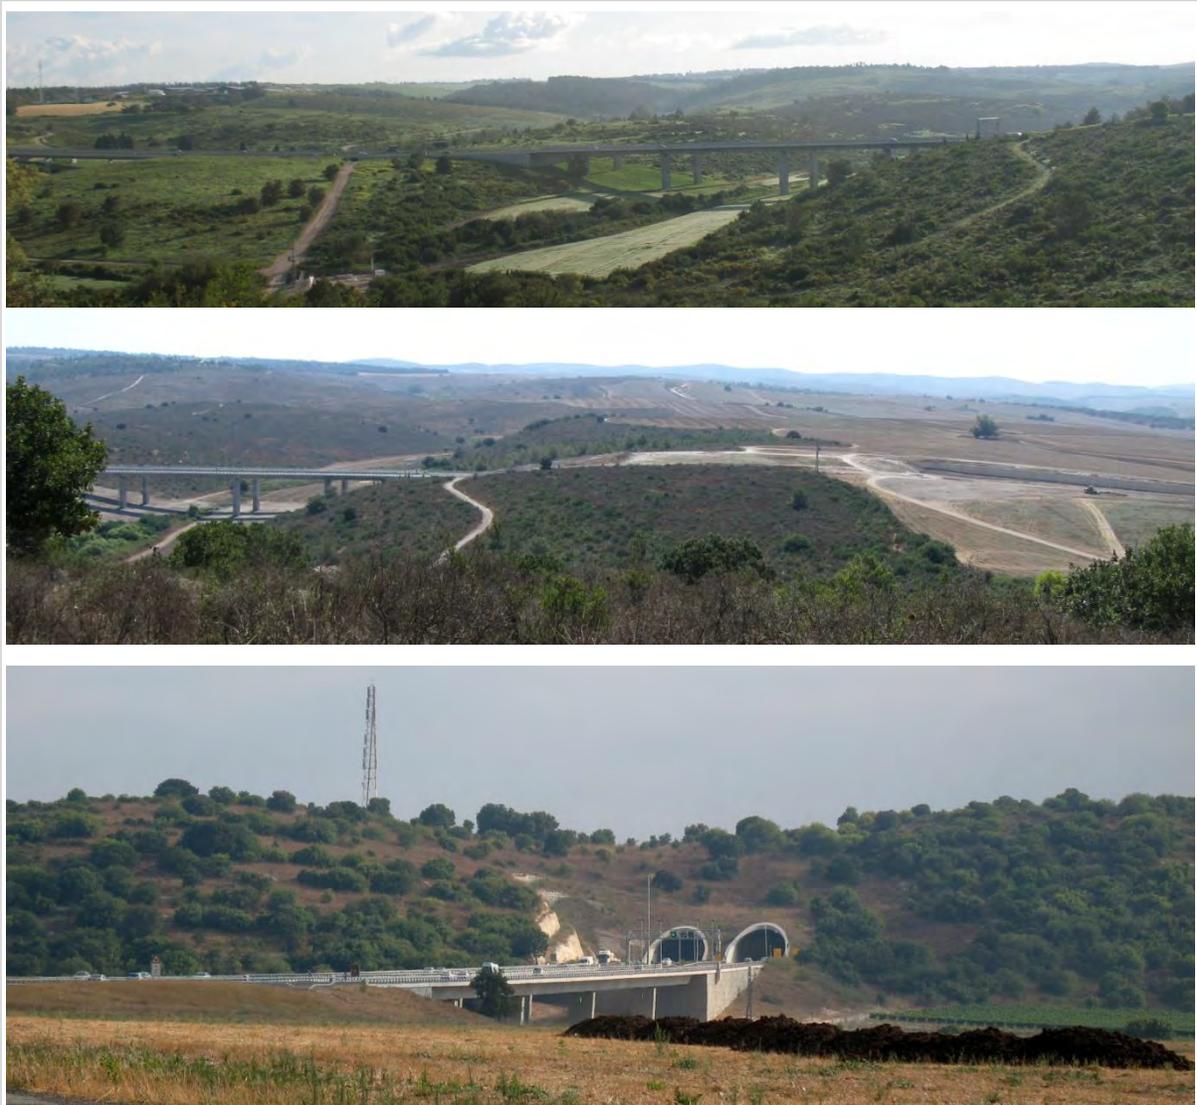
FIGURE 3 Two of the long bridges (top), the bridge linked to the cut & cover ecoduct (middle), the tunnel ecoduct (bottom).

The project was highly controversial and subject to public debate and opposition, largely on environmental issues, during the statutory planning phase. This led to a careful, detailed planning process that engaged the adoption of measures and standards many of which were applied in Israel for the first time. Among others, connectivity requirements were addressed, with the construction of 4 long bridges (ca 250m, 2x240m, 210m long) and 2 ecoducts (a 350m tunnel and a 150m cut & cover, Figure 3), along with many box culverts, fencing (variable mesh size, buried fence) and the implementation of a detailed monitoring program.

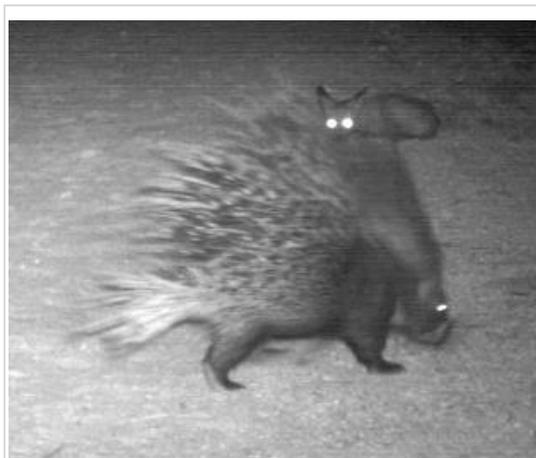
FIGURE 4 A Red Fox behind a Porcupine using the ecoduct.

Some individuals were seen feeding, playing and engaged in what seemed like territorial activity. In few cases, two cameras recorded different species present simultaneously on the passage, and one of them shows a fox closely behind a porcupine (Figure 4). Few species joined throughout the year.

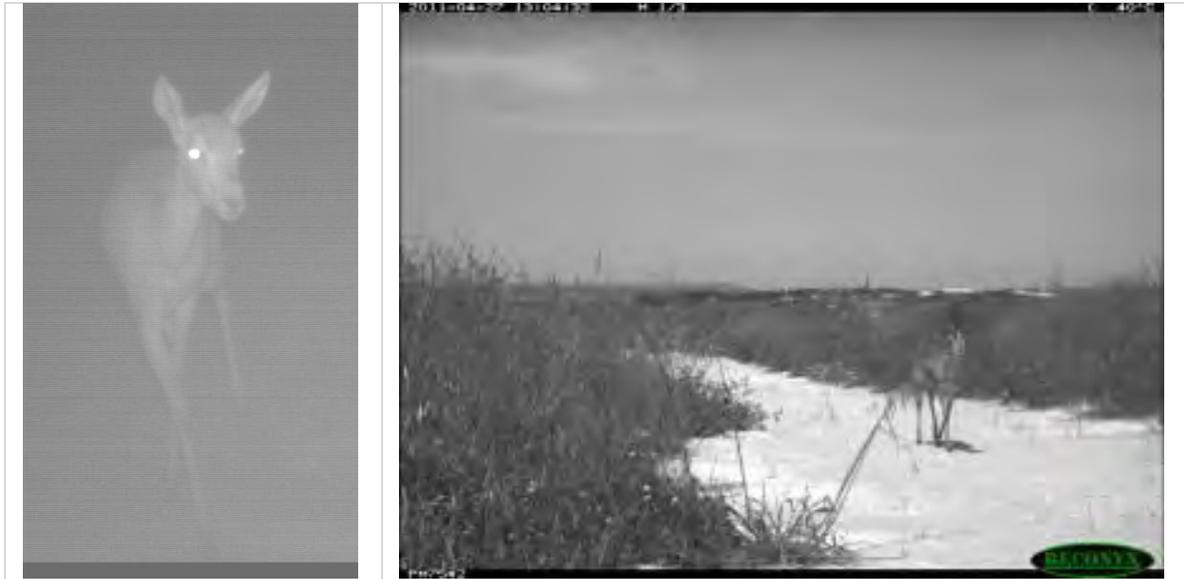
FIGURE 5 Two of the sightings of Mountain Gazelle on the cut & cover ecoduct.

Gazelles were recorded on the ecoduct 6 times during this year, two of them on two consecutive days in March. One of them (mid-January) with 3 females and the rest seemed to be a young individual, possibly dispersing, the latter 3 events may have been the same individual (Figure 5).

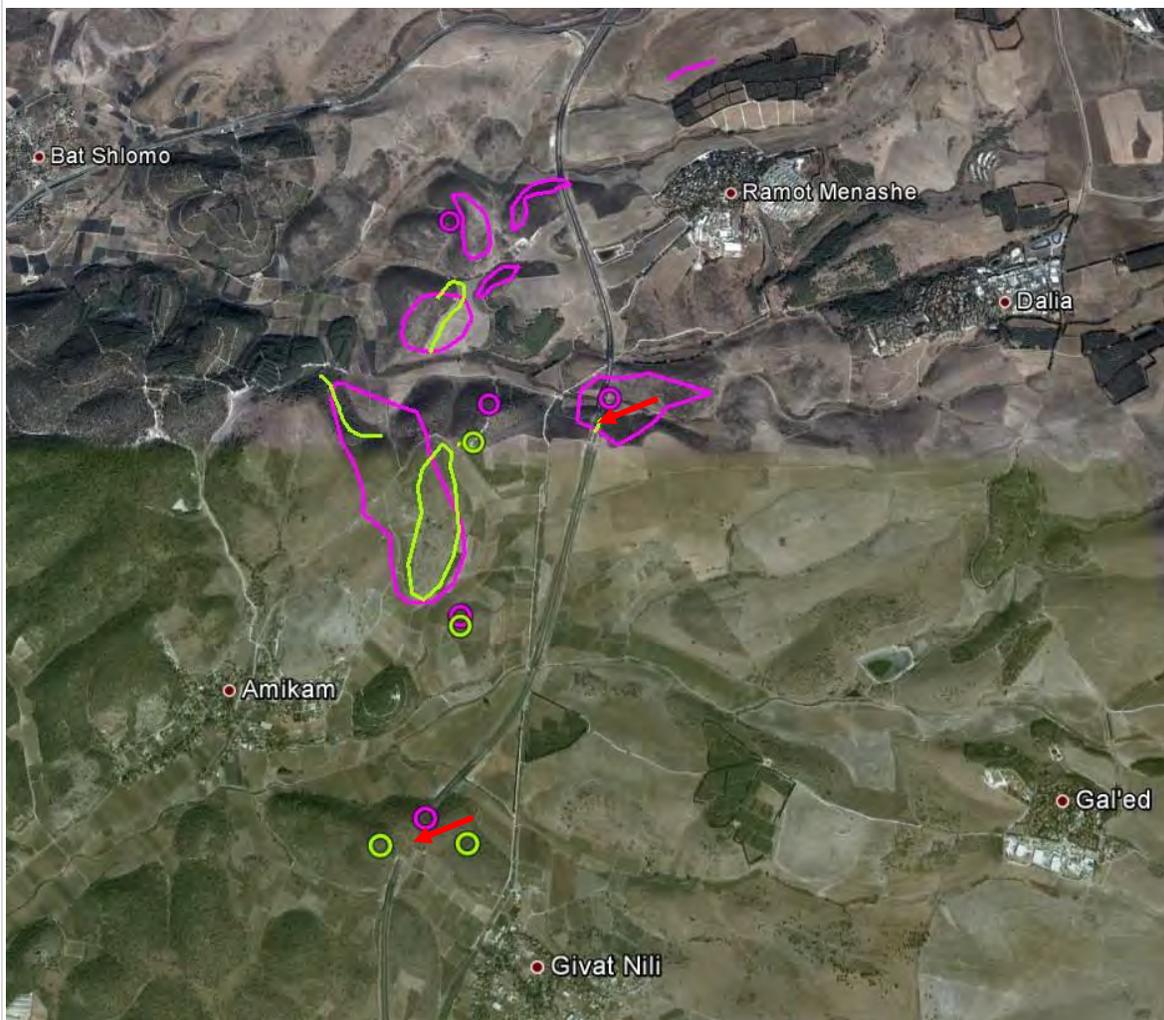
FIGURE 6 Location of gazelle records in P1 (2004-2005, in pink) and in P2 (2010-2011, in light green). Lines and polygons represent areas where animals were seen, circles represent points where feces and footprints were found. Red arrows mark the locations of the ecoducts.

Gazelle activity: Gazelles were recorded in both P1 and P2. In both phases most of the sightings were on the western side of the road (Figure 6). During P2, none were seen on transects or in other observations on the eastern side of the road, though local joggers and cyclists reported on occasional sightings there. Gazelles were recorded on both ecoducts but not under the bridges in P2, whereas in P1 few were also recorded in the planned location of the bridges. During P1 certain seasonal changes in the spatial pattern were detected, with more use of the eastern patches in winter and early spring. During P2 gazelle activity was observed on the western side of the road, in a more limited area (Figure 6). Due to the fewer observations in P2 it is difficult to detect such trend, if any.

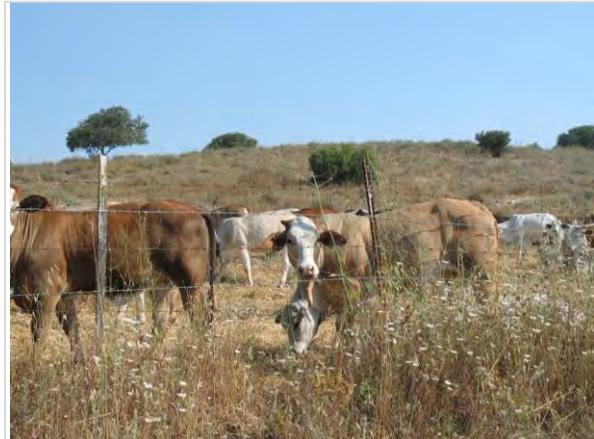
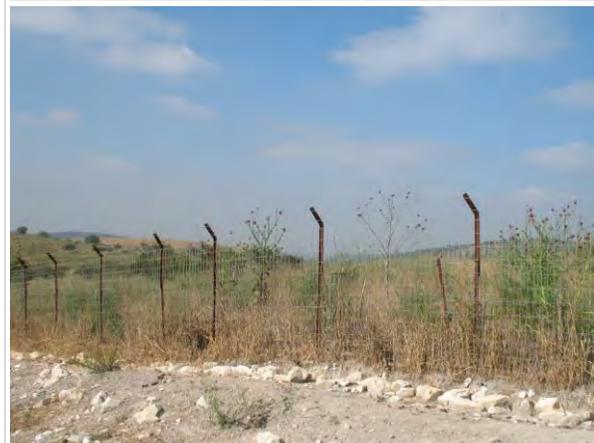
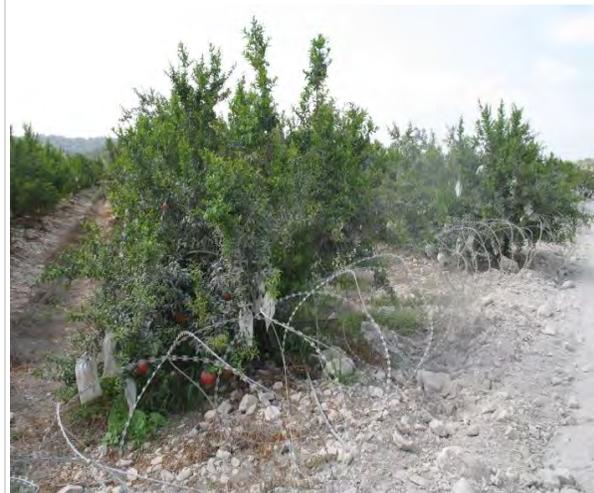
FIGURE 7 Few of the fencing types in the study area. Temporary fencing is shown at the bottom.

Agricultural fencing, aimed at both wildlife and human intruders, is a major issue as it introduces additional barriers which disturb animal movement and may limit overpass and underpass accessibility. Most of it is permanent fencing, with just few temporary fences (Figure 7). Between P1 and P2 more fences were installed, old fences were mended and wire density increased, possibly also due to a change in the policy of the ministry of agriculture and increased fencing subsidies for farmers. Figure 8 shows most of the fencing encountered during P2 alongside with the locations of gazelle sightings. Though some of the fences are not complete barriers, they may impede, disturb and reduce survival chances of at least some individuals of the larger species.
