**EXEMPLARY ECOSYSTEM INTIATIVE AWARD WINNER:
LAVA BUTTE US 97 WILDLIFE CROSSINGS IN BEND, OREGON**

New management approaches, including inter-agency collaboration, have been emerging to address multifaceted environmental challenges including mitigation of the ecological effects of roads. The Lava Butte US 97 wildlife crossings project in central Oregon is an example of collaborative cross-agency planning efforts and unique applied solutions to habitat connectivity and animal-vehicle collisions. The planning process incorporated several Eco-Logical concepts: early interagency coordination with an emphasis on meeting interagency mission objectives; an interagency mitigation design team that met regularly to plan, discuss and solve project issues; collaborative and creative funding using several sources; and an agreement to monitor effectiveness of the project despite a lack of immediately available funds. Each agency involved committed to furthering its portion of the objectives with specific actions: managing land adjacent to the crossing structures to enhance effectiveness of the structures (USDA Forest Service); monitoring and maintaining fencing (ODFW); and promoting public awa

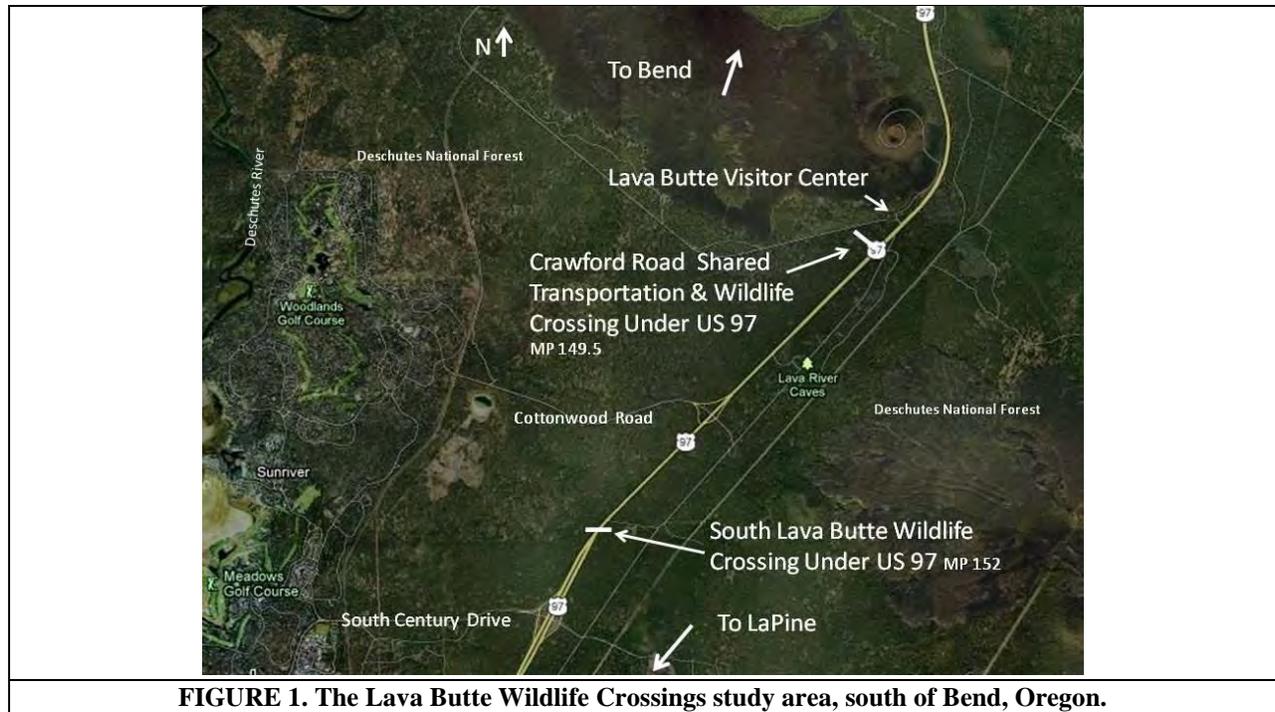
FIGURE 1. The Lava Butte Wildlife Crossings study area, south of Bend, Oregon.

US 97 is a major north-south route through central Oregon. The Lava Butte project area is approximately 15 miles south of Bend, in Deschutes County between Lava Butte at milepost 149 and S. Century Drive at milepost 153 (Figure 1). The project is entirely within the Deschutes National Forest with the north half also within the Newberry National Volcanic Monument. Traffic volume has been steadily increasing in the area and this project was initiated to increase capacity and safe access to recreational destinations including the Lava Lands Visitor Center and Lava River Cave. Project work included adding two lanes in the four-mile project area by constructing a new section parallel to the existing highway resulting in separated north and southbound traffic with a forested median, providing a full diamond interchange at Cottonwood Road, providing additional access points to the Lava Lands Visitor’s Center and Lava River Cave as well as building road shoulders to accommodate bicyclists.

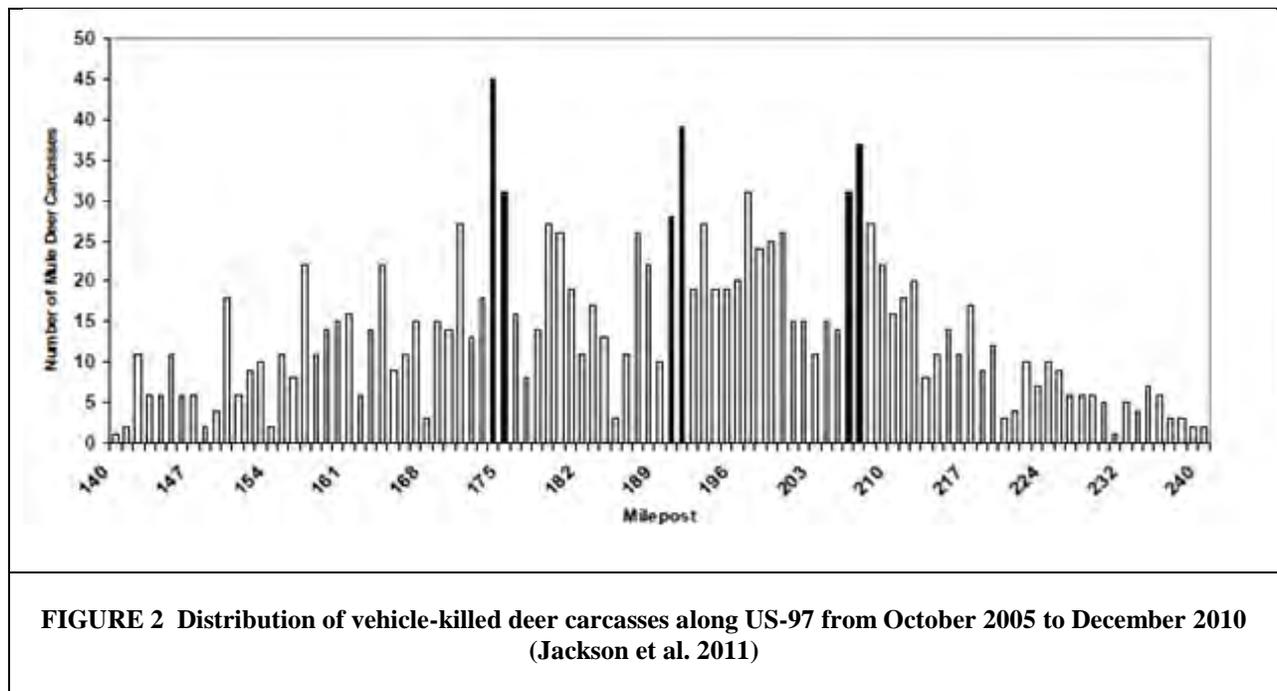
FIGURE 2 Distribution of vehicle-killed deer carcasses along US-97 from October 2005 to December 2010 (Jackson et al. 2011)

Although the Lava Butte project area does not have the highest rates of deer-vehicle collisions in the 100-mile mule deer migration study area (Figure 2), interagency stakeholders believe that wildlife mitigation measures were warranted to reduce animal-vehicle collisions, restore the mule deer migration pathway and provide habitat connectivity for all species across this section of US 97. Two bridged wildlife crossing structures were included in the highway widening project that allow wildlife to pass under the highway and access habitat on either side (Figure 3).

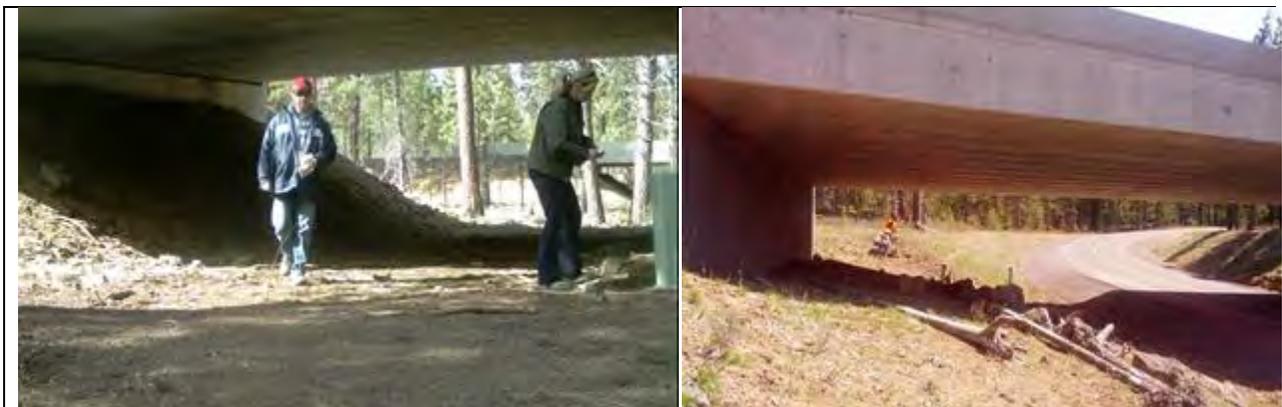
FIGURE 3 Wildlife crossing structures. The south Lava Butte crossing (left) note the view of the forested median and paired structure in the background. The Crawford Road combined crossing structure (right) as seen from the median point along the wildlife path.

At the southern end of the project, the south Lava Butte crossing structure is dedicated solely to wildlife, with no vehicular traffic present. The second (northern) structure was designed as a multi-use structure with a low volume and seasonally closed road (Crawford Road) for access to the Lava Butte Visitor Center as well as a separated wildlife path. In considering inclusion of the combined crossing structure the design team was faced with the choice of only including a single wildlife crossing structure within the project or to also combine a wildlife component with the access road in an attempt to accommodate traffic and wildlife, resulting in two crossing structures. This combined passage provides a unique research opportunity to assess passage use and more closely examine possible temporal shifts in use by wildlife both seasonally and daily.

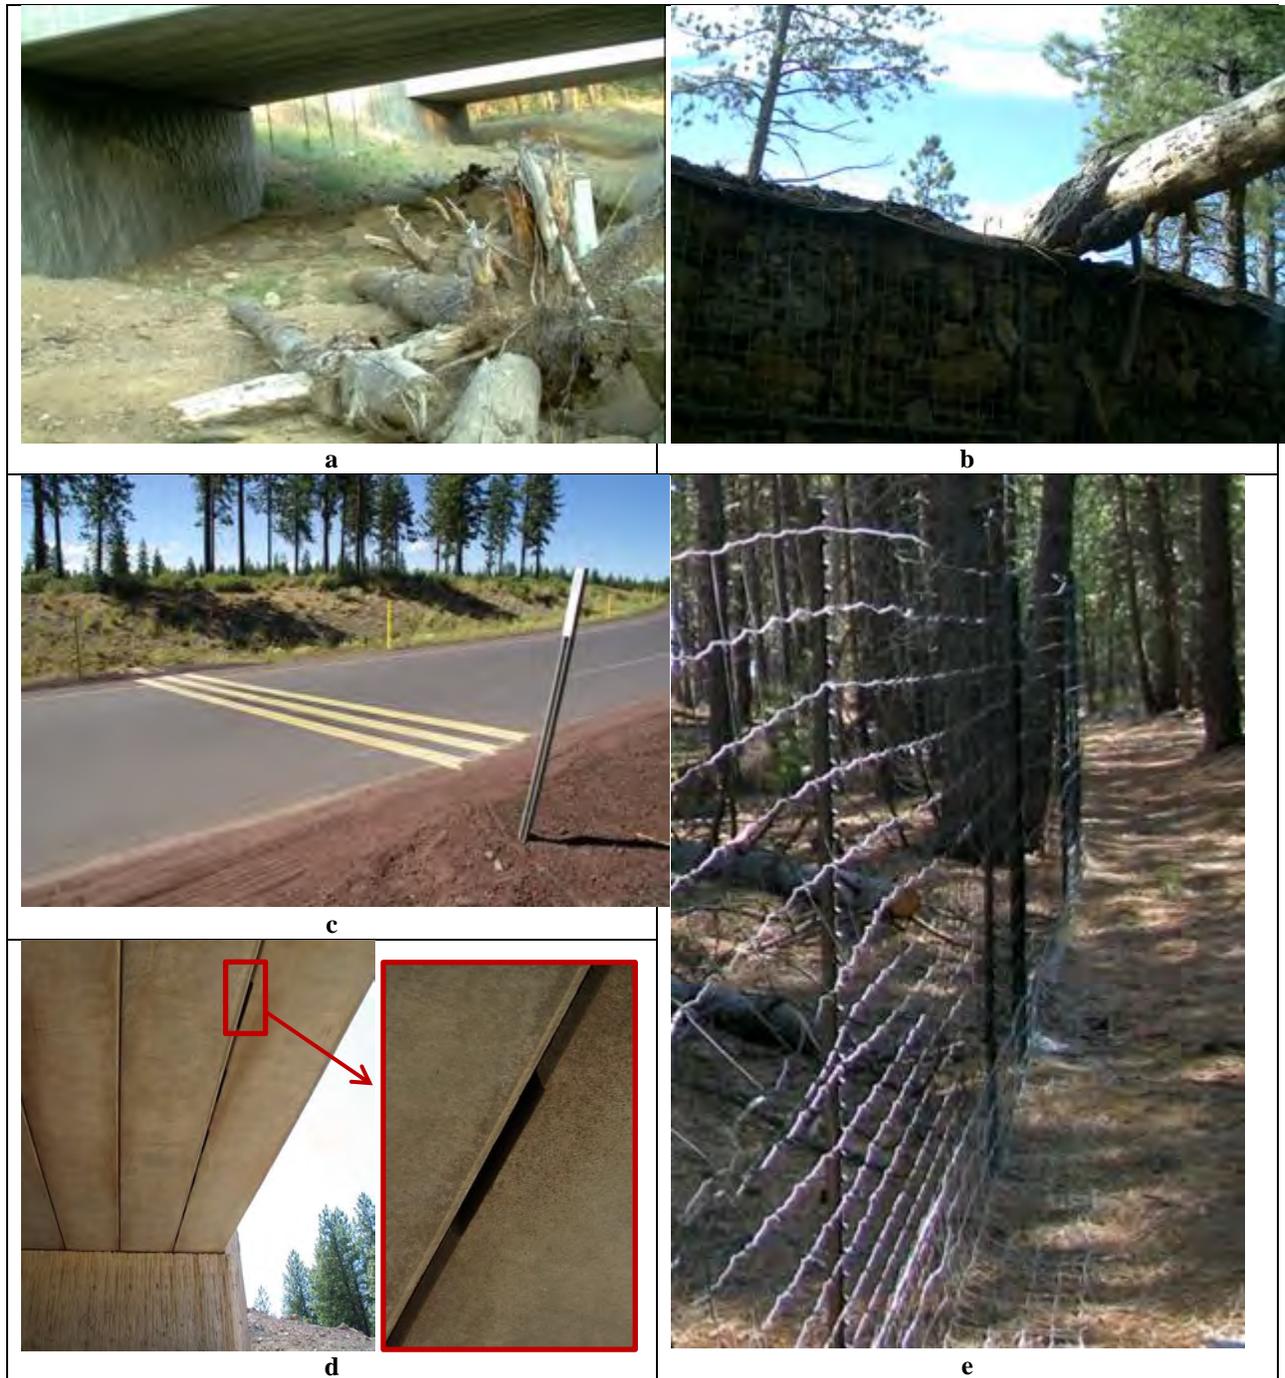
FIGURE 4 Additional wildlife features of the Lava Butte project
a) Habitat structure at the Crawford Road crossing, b) View of a jumpout from the wild-side of the fence, c) ElectroBraid™ mats pictured previous to fence installation, d) Bat Crevices, e) Exclusionary fencing

Wildlife features implemented in this project to encourage wildlife use of the structures and deter them away from the busy highway include habitat structure and native plantings, wildlife exclusionary fencing, jumpout escape ramps and ElectroBraid™ mats (Figure 4). Crevices were also included in the crossing structure design to provide roosting habitat for local bat species. Wildlife crossing structures were enhanced with materials to increase habitat complexity, promote the growth of native vegetation and to encourage small mammal use. Logs and large rock were added to provide cover and structure for small animal crossing use. Topsoil was retained and amended within crossing to improve water retention. In order to increase native plant colonization and establishment success, native plants were salvaged from the project area pre-construction and stored in the Forest Service nursery then replanted post-construction. The Lava Butte project also installed four miles (6.4 km) of wildlife exclusionary fencing along both sides of the highway. The wire fencing is 8 ft (2.4m) high and was designed for both large and small animals. The wildlife fencing includes increasingly small gaps in the fencing from top to bottom as well as flaring the fencing material at the bottom to deter burrowing animals from digging under the fence. Jumpout escape ramps were installed in four locations within the fenced project area. These structures used a gabion style design, covered with earth to create an elevated area allowing wildlife to jump essentially over the exclusionary fencing and back to the surrounding habitat. ElectroBraid™ mats were installed across six road access points to prevent wildlife from entering the road right of way at intersections.

Exclusion fencing design and conceptualization did not match the on-the-ground result. Because the design group did not specify explicitly enough the desired gap size of the fence, the gaps ended up too large to prevent smaller animals from accessing the road surface. The error was detected after all of the customized, vinyl-coated black mesh fence was purchased, and could not be replaced.

In constructing the jumpout structures a gabion style was used, however this style was not a good fit for the porous soil in this setting. In the design concept, it was believed that soil would cover the wire structure. Unfortunately this was not the case and now there is exposed gabion mesh, creating the possibility of hooves or other wildlife appendages getting stuck in the jumpout structure. Also the specific locations of the jumpout features on the project plans were intended by the design team to be general and then field fit with help from the design team, but without coordination during the construction phase, they were placed exactly as per plans. Without the microsite and topography considerations the jumpouts were not placed in ideal locations within the project area and may have reduced functionality as a result.

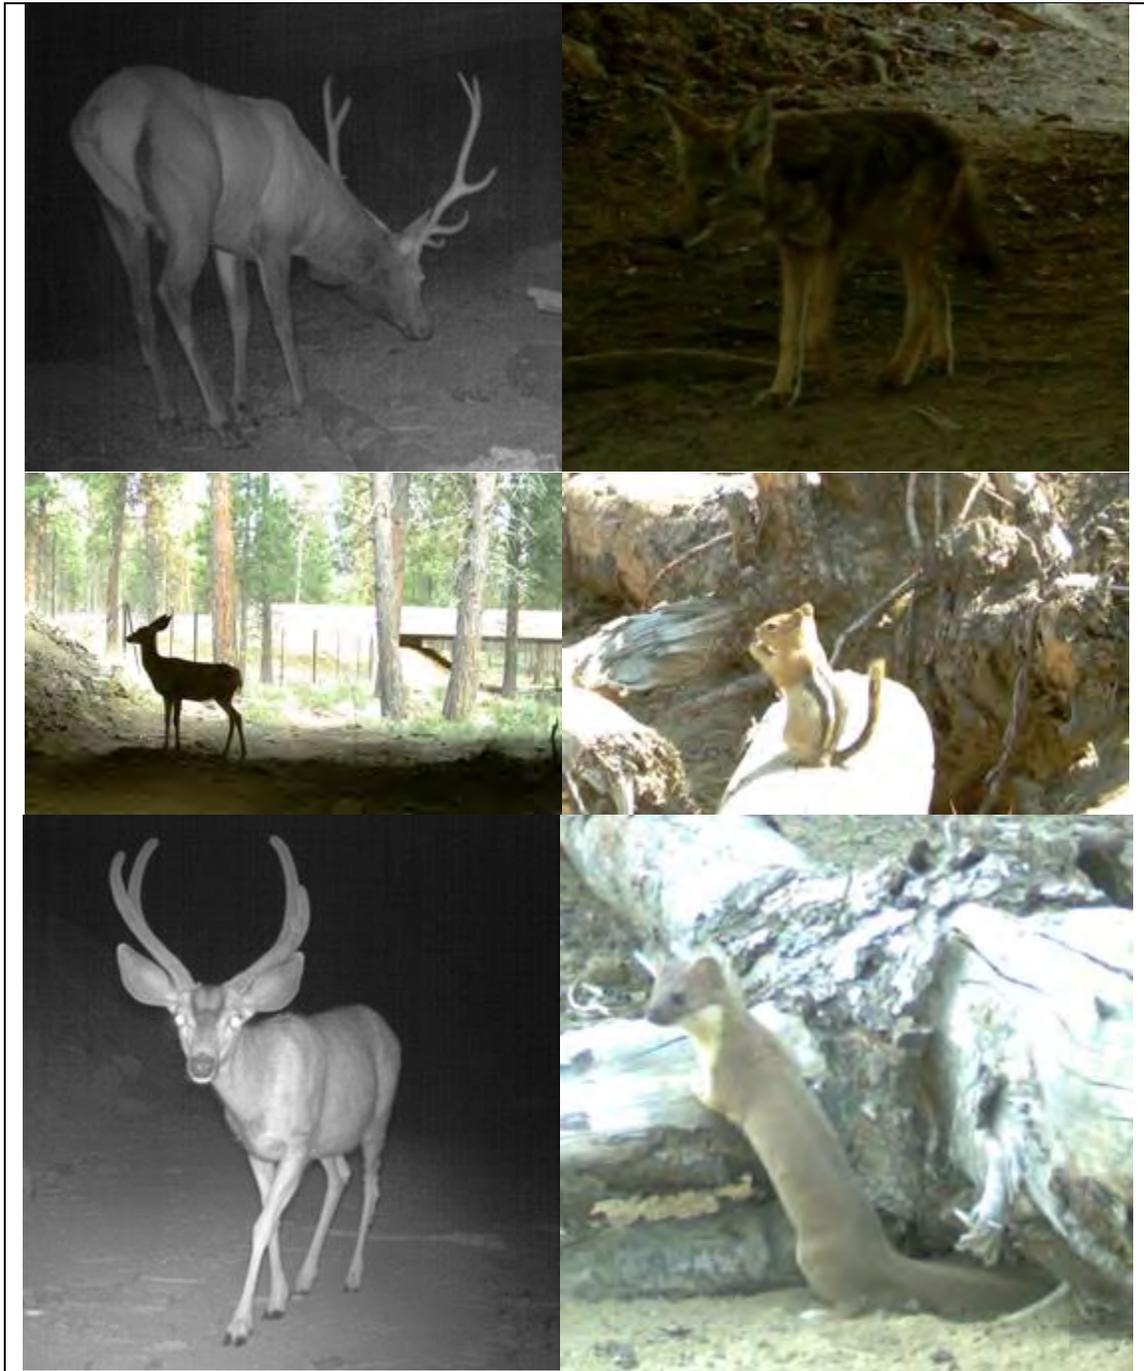
FIGURE 5 A sample of wildlife documented at the Lava Butte wildlife crossings. Species pictured include elk, coyote, mule deer, ground squirrel and weasel.

Restoration of the mule deer migration pathway and habitat connectivity for all species is currently being assessed by documenting successful use of the crossing structures. ODOT installed seven Reconyx motion detect cameras at the Crawford Road crossing structures, and four cameras on the South Lava Butte structure. A selection of the cameras within each crossing structure are positioned with the objective of capturing large animal movements to document mule deer activity while the remaining cameras are positioned to better capture smaller animal movement, particularly near habitat structure features within the crossing structure. Multiple research questions may be assessed with this study design, including to: evaluate wildlife use and repels of the structures; determine the diversity of species using the crossings; determining the frequency of each species using the crossing; and observe if mule deer, elk, and other wildlife use increases over time. Passage monitoring will also allow for a comparison of wildlife activity between the multi-use Crawford Road crossing and the wildlife-dedicated south Lava Butte crossing, as well as the potential effects of low volume traffic on wildlife use of a crossing structure. Since installation of the motion detect cameras many successful and attempted crossings have been documented for a variety of species including mule deer, coyote, badger, rabbit and ground squirrel (**Figure 5**).
