**A WILDLIFE BARRIER FENCE NORTH OF WENATCHEE, WASHINGTON:
LEARNING EXPERIENCES INVOLVING RUGGED COUNTRY AND CUSTOM
DESIGNED WILDLIFE GUARDS AND JUMPOUTS**

ABSTRACT

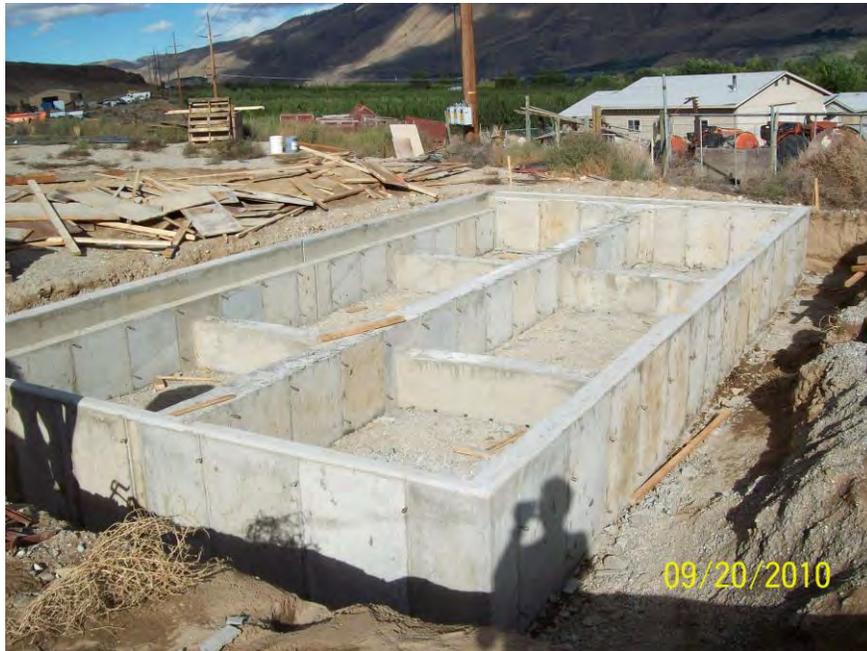
FIGURE 1. Custom designed foundation for one of ten wildlife guards built for the project

Ten frequently used side roads access the highway in the fenced stretch. These roads vary in their widths and, rather than purchasing pre-fabricated and commercially available cattle guards, WSDOT chose to design its own. The guards that were built ranged from 4.9 m (16 ft) to 9.8 m (32 ft) in width. The dimension in the direction of travel was consistently 4.9 m (16 ft). For the base of the guards, 0.9 meter (3

ft) deep holes were excavated and concrete forms constructed inside each one (Fig. 1). Anchor bolts were installed in the concrete base for affixing the steel grate surface. Wildlife guards were flanked, on each side, by 4.9 m (16 ft) wide rigid cattle panels.

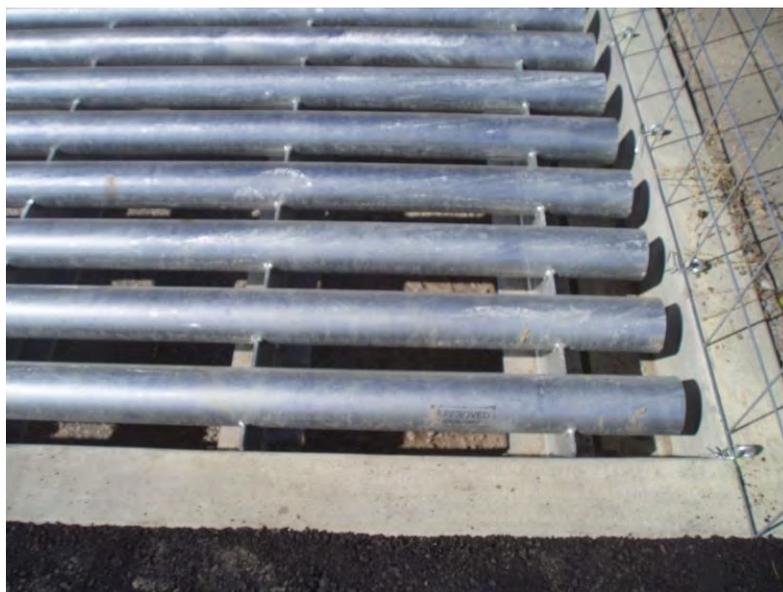
FIGURE 3. WSDOT's final wildlife guard design employed round pipe for cross pieces.

Efforts to test the effectiveness of the wildlife guard design included leading a pet goat over a guard (Fig. 2). The goat was able to cross fairly easily. A retrofit was implemented, removing the strap steel and welding angle iron across the tubular steel so that sharp right angles on each cross-piece pointed skyward, creating more precarious footing. Monitoring with trail cameras showed that mule deer were generally wary, usually turning away but sometimes bounding across. Rabbits, bobcat and a cougar were also observed, by camera, crossing over the wildlife guards. In response to these results, the final design substituted cross pieces made from 3-4 inch diameter round pipe (Fig. 3). This final version represents the culmination of a prolonged effort to adaptively respond to perceived or proven weaknesses in the earlier designs.

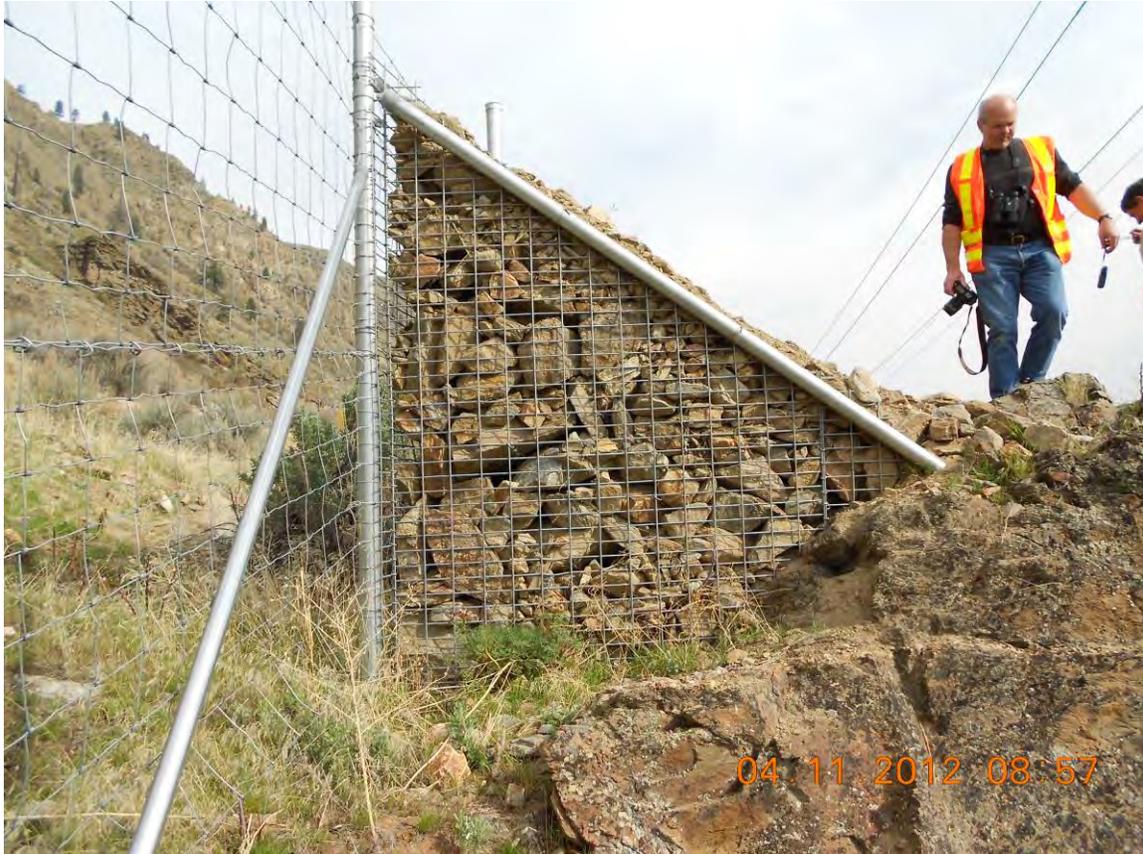
FIGURE 4. Jumpout designed for bighorn sheep was placed atop a rock outcrop.

Four jumpouts were built as well, each a different design. One of them, a relatively steep and rocky ramp, was built on top of a rock outcrop, designed specifically to be attractive to bighorn sheep (Fig. 4). Rock-filled gabions were used to form the face of other jumpouts (Fig. 5).

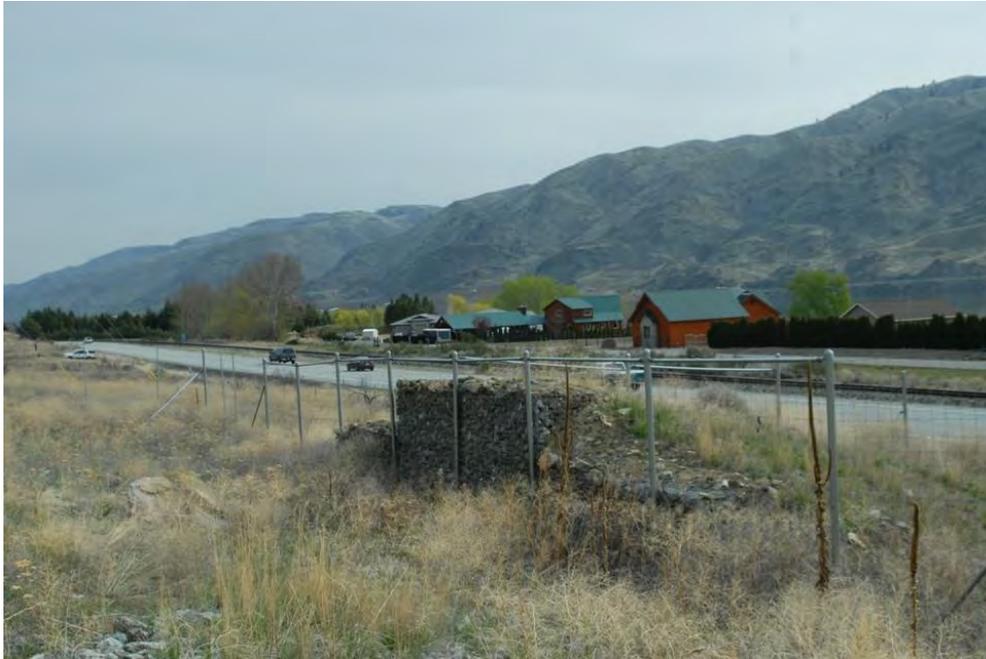
FIGURE 5. Jumpout built with rock gabions and fill.

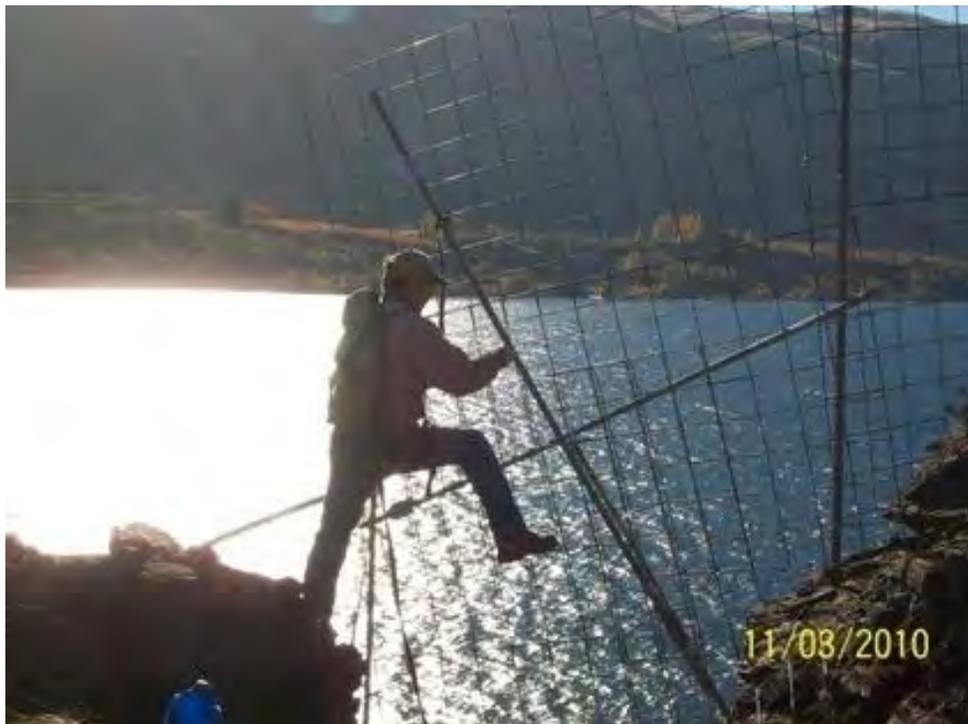
FIGURE 6. A rigid cattle panel is placed where bighorn sheep might otherwise get around a fence end.

This stretch of highway, paralleling the Columbia River, is bordered by an abundance of rocky slopes, including outcrops of solid rock and some areas with vertical rock faces. These provided significant challenges to building an effective fence, especially given the known ability of bighorn sheep to traverse many of the steepest cliffs. There were instances where a vertical rock face was an adequate barrier to movement of sheep. In these locations, the fence was bolted to the rock at either end of the cliff face. This was accomplished using eye bolts anchored into bored holes using epoxy resin. Where the terrain dropped off almost vertically, rigid 2.4 m (8 ft) cattle panels were extended out over the edge to prevent animals from skirting around the end of the fence (Fig. 6). Chain link fencing was also used, at the base of steep rock faces, because of its greater rigidity and durability to hold up under conditions of frequent rock fall.
