Aquatics and Marine Ecosystems

RESTORATION OF AQUATIC HABITAT AND FISH PASSAGE DEGRADED BY WIDENING OF INDIAN HIGHWAY 58 IN GARHWAL HIMALAYA

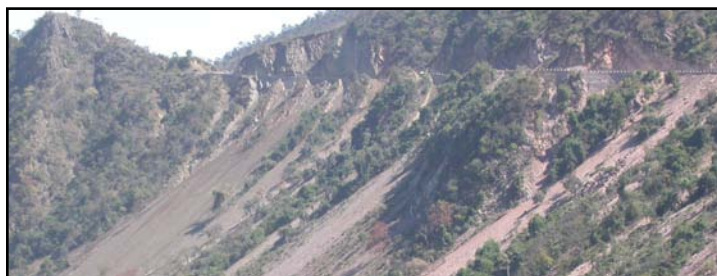
Figure 1. Disposal of cut material downhill into the Alaknanda River caused by the widening activities on NH-58.

A large-scale morphometric transformation of the habitat of Snow Trout in a large section of the Alaknanda River has taken place due to widening activities on NH-58. As a consequence of these construction activities accompanying the road widening, a large stretch of the fluvial system has been transformed into a trench and a dammed pool of sluggish currents of water from rapids, cascades, and part of the high water from riffles. The other section of the river has been converted into narrow, turbulent, and turbid riffles from white and clear water pools as a result of the large scale of disturbances caused by disposal of tons of cut material downhill into the waterways of the Alaknanda River (figure 1).

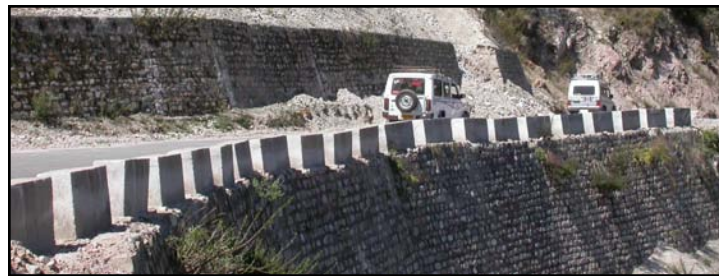
Figure 6. Early failure of toe wall due to heavy precipitation during monsoon (July-August) on NH-58.

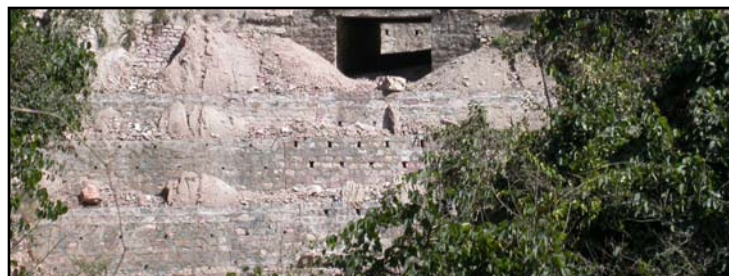
Figure 7. Construction of big culverts and check dams along NH-58 for proper drainage.

The activity of widening of NH-58 is a massive interference with the environment. Therefore, it should be handled with the utmost care. Thus 'kid-glove' approaches to road construction and widening should be applied, which include automatically the principle of preventing and minimizing erosion. Following this concept, slope failures have to be immediately repaired to prevent further extension and avoid the possibility that they become uncontrollable. Where the water runoff is not tightly checked, the system has to be improved to prevent creeps and slides. Early failures of the toe walls due to heavy precipitation during monsoon season (July-August) are very common in Garhwal Himalaya (figure 6). Therefore, several big culverts and check dams have been constructed for proper drainage throughout the length of NH-58 along the Alaknanda River in Garhwal Himalaya (figure 7).
